## TREE INSPECTION REPORT

<b>Report number:</b> 24669	<b>Site address of tree:</b> 3459 Warburton Highway, Warburton	
<b>Date of inspection:</b> 27/11/2022	<b>Melway:</b> 290 C4	
<b>Name:</b>	<b>Address:</b>	<b>Phone:</b>
<b>Recommended action:</b> Remove tree, second opinion requested		
<b>Reasons for recommended action:</b> <p>The tree is large and prominent, it has been cabled twice along the codominant stems. the trunks are now likely to be being held together by the cables rather than as supplementary support.</p> <p>The crack on the northside is now down to the root flare and there are small soil cracks. The 1m probe could be inserted the full length into the crack.</p> <p>The western stem has a significant split and cavity from 3-7m along the trunk. Numerous black Ants were evident suggesting additional cavities not spotted.</p> <p>The larger stem has a patch of decay at the base.</p> <p>This tree has been in a state of structural decline for some time. Determination of retention should be based on any signs of change in structure, not just the way it presents today.</p>

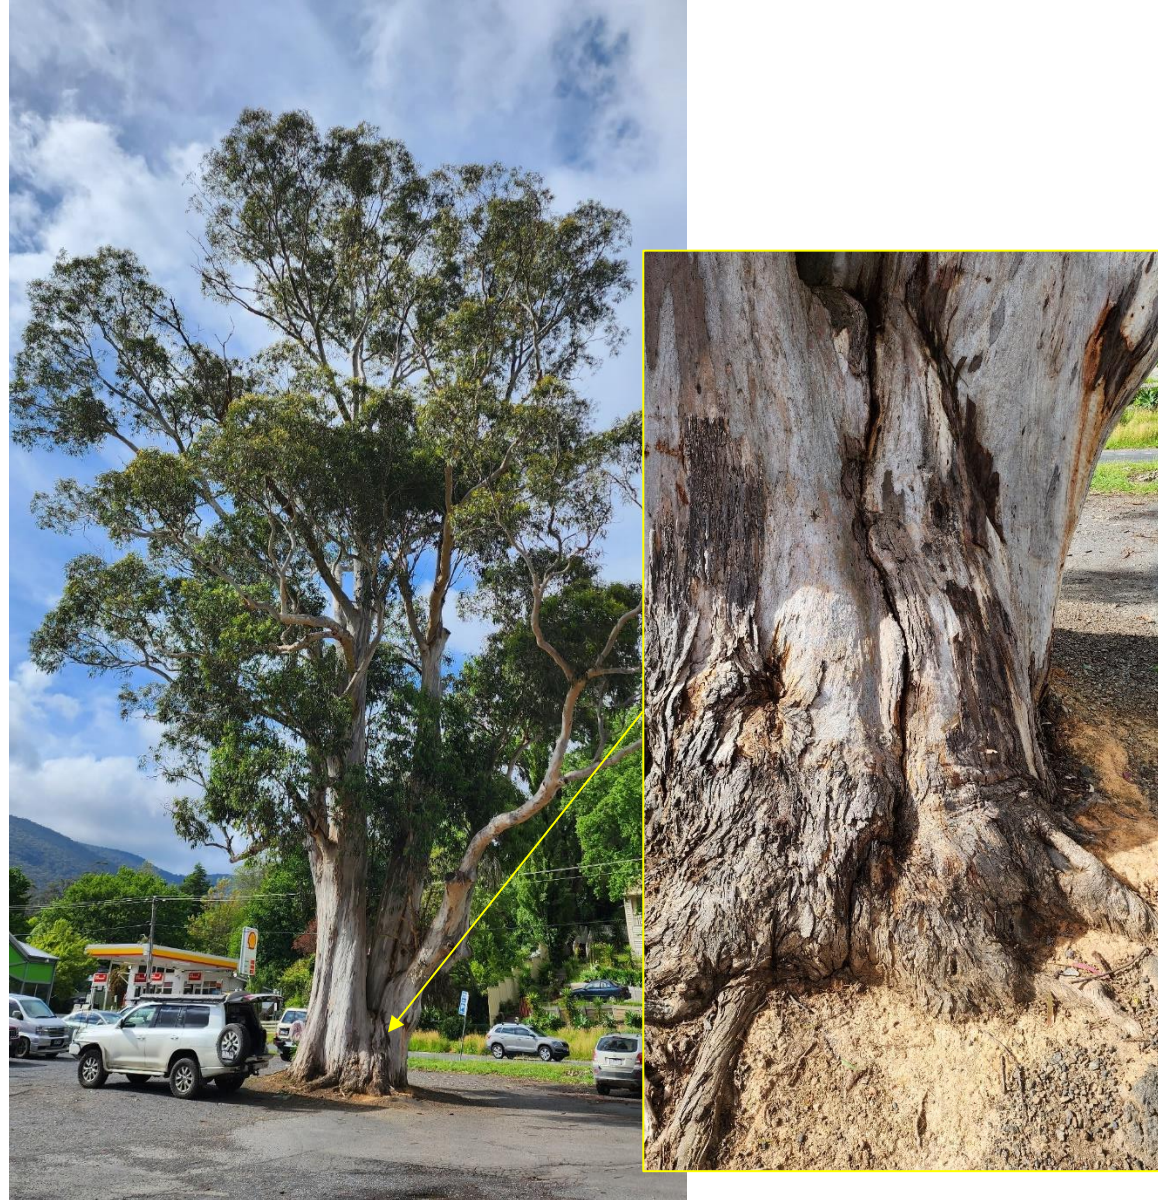
Photo 1

<b>Age:</b> Mature		<b>Common name:</b> Mountain Grey Gum		<b>Botanical name:</b> <i>E. cypellocarpa</i>	
<b>Tree No.</b> 1	<b>Height (m)</b> 33	<b>Spread (m)</b> 20		<b>DBH (mm)</b> 268	
<b>Roots condition:</b> Growing in asphalt/gravel car park			<b>Trunk condition:</b> Poor, decay at base. codominant split to ground level through root flare. Crack in western stem at 3-7m. Cavity in eastern stem at 5m. Codominant stems cabled.		
<b>Limbs condition:</b> Fair, previously pruned, failures evident			<b>Foliage condition:</b> Good		
Amenity value: High			<b>Habitat:</b> <i>Part of habitat corridor:</i> No <i>Hollow bearing:</i> Yes <i>Native Fauna Use:</i> Likely		
<b>Distance to building (m):</b> ~25		<b>Do branches overhang buildings?</b> No		<b>Targets</b>  Carpark, cars, pedestrians.	
<b>Company:</b> Ryder Consulting		<b>Name:</b>		<b>Date report written up:</b> 27/11/2022

Tree 1 with crack to ground level (inset)

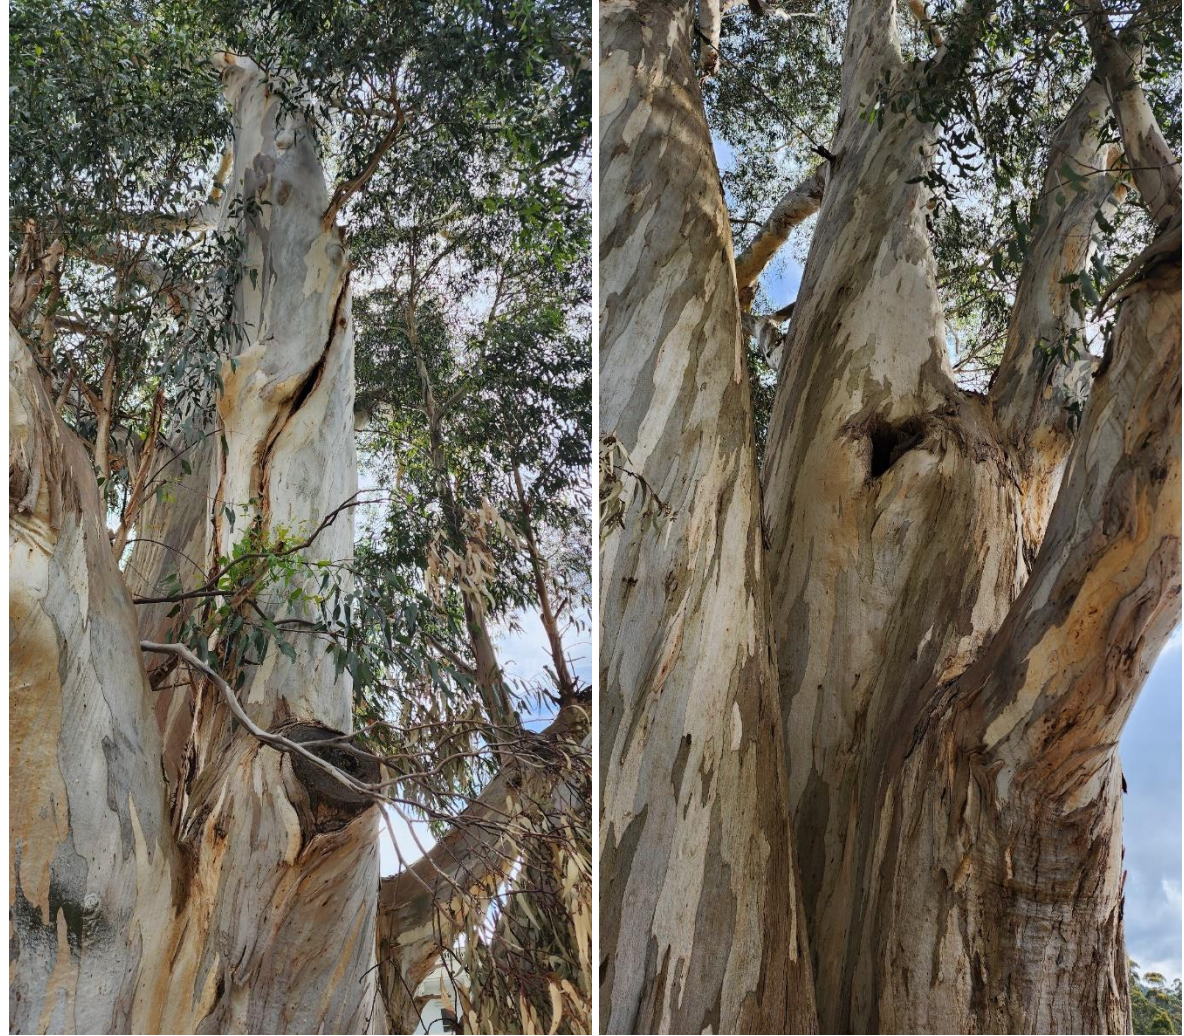
Photo 2

Split in western stem and cavity in eastern stem
