# Division 6 Hazardous Building Materials Assessment

Yarra Ranges Council Offices  
15 Anderson Street  
Lilydale, Victoria

Yarra Ranges Council

April 2016 (Revision 1)

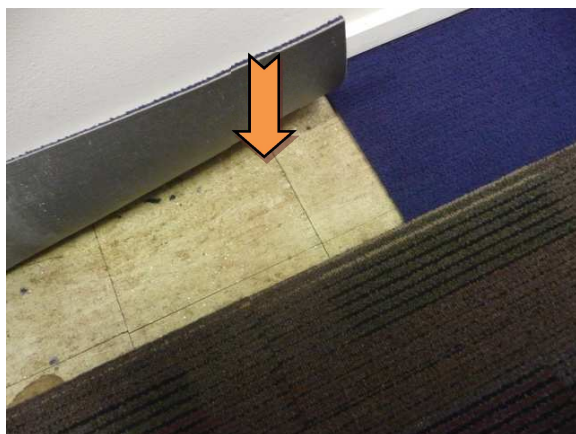
Ground level - Civic Space Offices	Throughout	Flooring under carpet	Beige brittle vinyl floor tile	Asbestos	19952-001-001A	Positive	Non-friable	Low	Good	Low	~350m²	Label as containing asbestos and maintain in current condition if to remain in-situ, remove under controlled bonded asbestos removal conditions prior to refurbishment or demolition works by a Class B (bonded) licensed asbestos removal contractor.	P4	Mar-21	1
Ground level - Civic Space Offices	Throughout	Flooring under carpet	Yellow adhesive	Asbestos	19952-001-001B	Negative	-	-	-	-	-	-	-	-	-
Ground level - Main Building	Call Centre & Hallways	Flooring under carpet	Beige brittle vinyl floor tile	Asbestos	Similar to 19952-001-001A	Assumed Positive	Non-friable	Low ~	Good	Low	~350m²	Label as containing asbestos and maintain in current condition if to remain in-situ, remove under controlled bonded asbestos removal conditions prior to refurbishment or demolition works by a Class B (bonded) licensed asbestos removal contractor.	P4	Mar-21	2

**Photo 1.** Main Building – ground level – under carpet tiles – asbestos vinyl floor tiles – Sample 19952-001-001A.

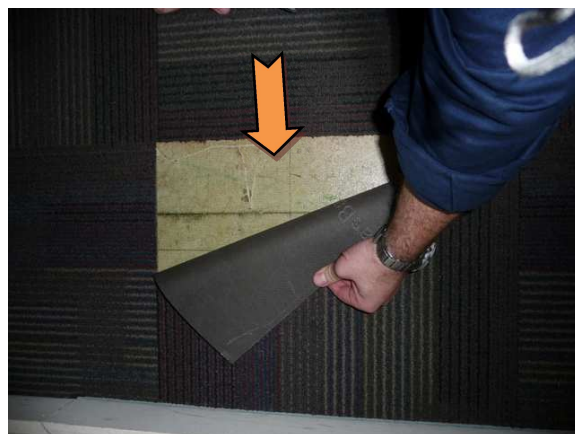
**Photo 2.** Main Building – ground floor call centre – under carpet tiles – assumed asbestos vinyl floor tiles.

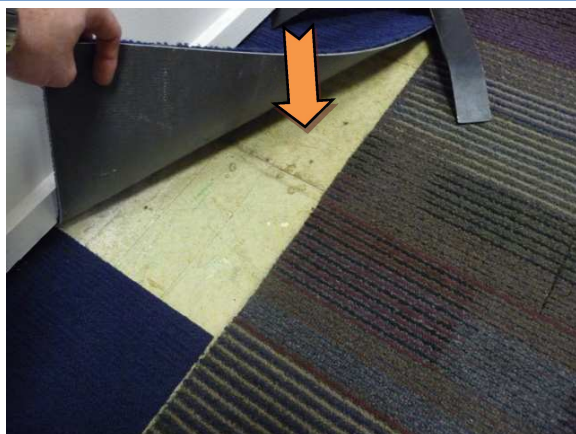
**Photo 3.** Main Building – Governance/CEO Area – under carpet tiles – asbestos vinyl wall tiles – Sample 19952-001-003A.

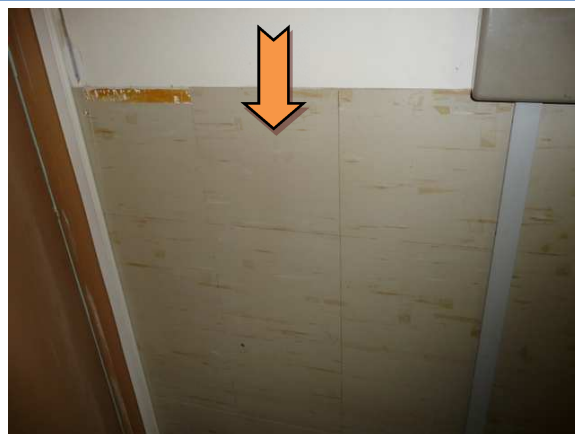
Ground level - Main Building	Comms/Store 2/IT Room	Wall tiles	Beige brittle vinyl floor tile	Asbestos	19952-001-012A	Positive	Non-friable	Low	Good	Low	~8m²	Maintain in current condition if to remain in-situ. Remove under controlled bonded asbestos removal conditions prior to refurbishment or demolition works by a Class B (bonded) licensed asbestos removal contractor.	P4	Mar-21	4
Ground level - Main Building	Comms/Store 2/IT Room	Wall tiles	Yellow adhesive	Asbestos	19952-001-012B	Negative	-	-	-	-	-	-	-	-	-

**Photo 4.** Main Building – IT/Comms room – walls – asbestos vinyl wall tiles – Sample 19952-001-0012A.

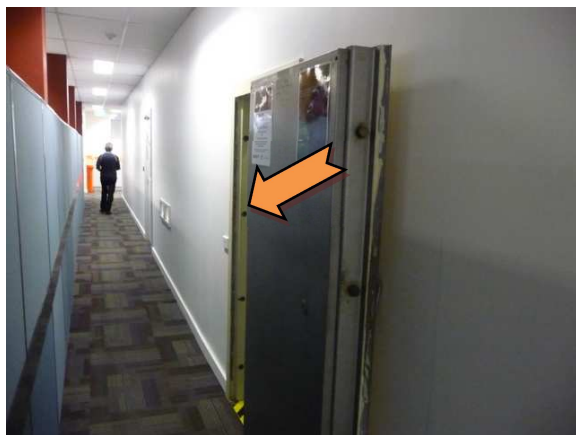
Area / Level	Room & Location	Feature	Item Description	Hazard Type	Sample No.	Sample Status	Friability	Disturb. Potential	Condition	Risk Status	Quantity	Recommendations & Comments	Control Priority	Reinspect date	Photo No.
Ground level - Main Building	Kitchen 1	Flooring	Green vinyl floor tiles	Asbestos	19952-001-014	Negative	-	-	-	-	-	-	-	-	-
Ground level - Main Building	Throughout	Skirting	Black flexible sheet vinyl	Asbestos	19952-001-013	Negative	-	-	-	-	-	-	-	-	-
Ground level - Main Building	Male & Female WC 3	Flooring	Black vinyl floor tiles	Asbestos	Similar to 19952-001-014	Assumed Negative	-	-	-	-	-	-	-	-	-
Ground level - Main Building	Room Safe 1	Safe door	Fibre cement sheet	Asbestos	-	Assumed Positive	Non-friable	Low	Good	Low	1 Unit	Maintain in current condition if to remain in-situ. Remove under controlled bonded asbestos removal conditions prior to refurbishment or demolition works by a Class B (bonded) licensed asbestos removal contractor.	P4	Mar-21	5

**Photo 5.** Main Building – ground floor – safe room 1 – assumed internal asbestos-containing fibre cement sheet.

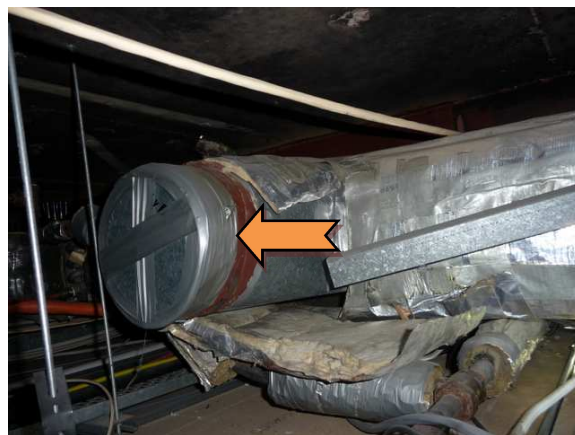
**Photo 6.** Main Building – Call Centre – asbestos mastic to joins in ductwork – Sample 19952-001-015.

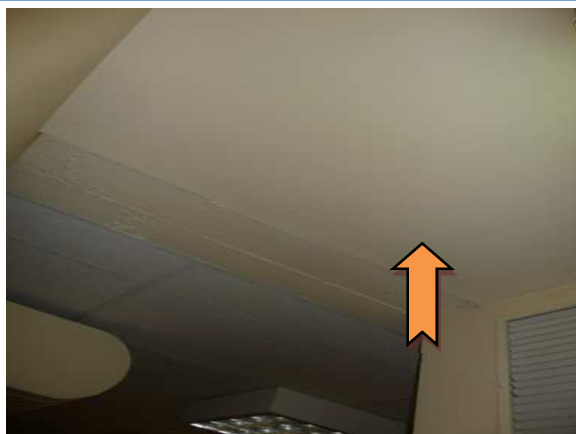
**Photo 9.** Main Building – basement corridor ceiling – asbestos cement. Sample 19952-001-024.

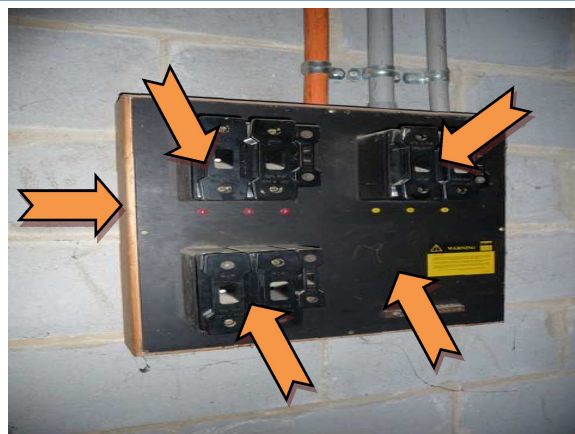
**Photo 10.** Main Building basement – Plant Area 2 – assumed asbestos millboard lining, bituminous board and HRC fuses

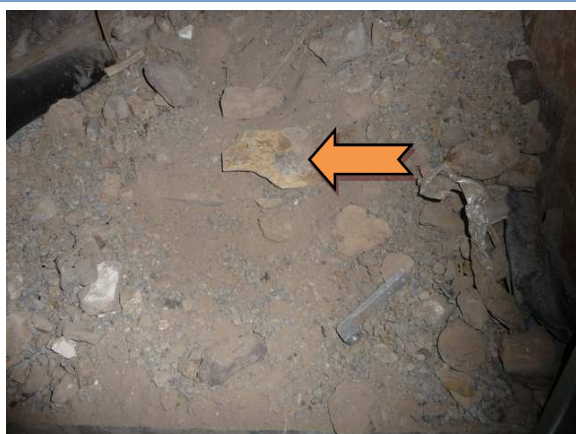
**Photo 11.** Main Building basement – Plant Area 2 – rubble - asbestos vinyl tile debris. Sample 19952-001-025A.

- The vinyl floor tile debris located in the Plant Area 2 should be removed by an appropriately licensed contractor.
- Asbestos-containing building materials that are likely to be disturbed by the future demolition and refurbishment works should be removed prior to the commencement of the works. The asbestos removal works should be conducted by an appropriately licensed asbestos removal contractor under controlled asbestos removal working conditions.

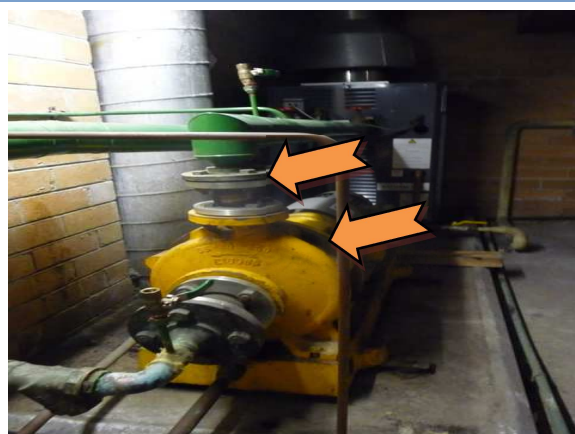
**Photo 12.** Main Building basement – Plant Area 1 – pump unit - assumed asbestos gaskets.

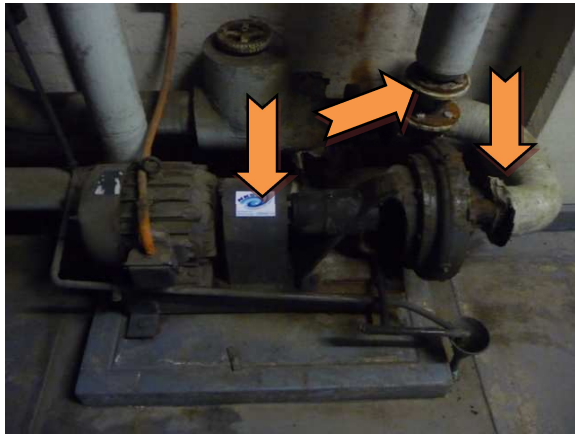
**Photo 13.** Main Building basement – Plant Area 3 – pipework and pump unit - asbestos gaskets. Sample 19952-001-033.

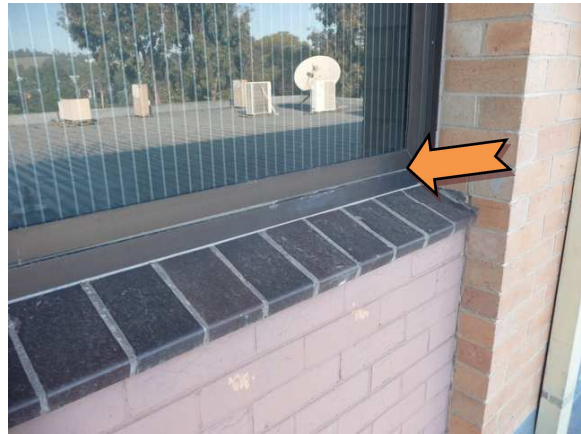
**Photo 14.** External roof area Main Building – windows throughout – asbestos-containing mastic – Sample 19952-002-002.

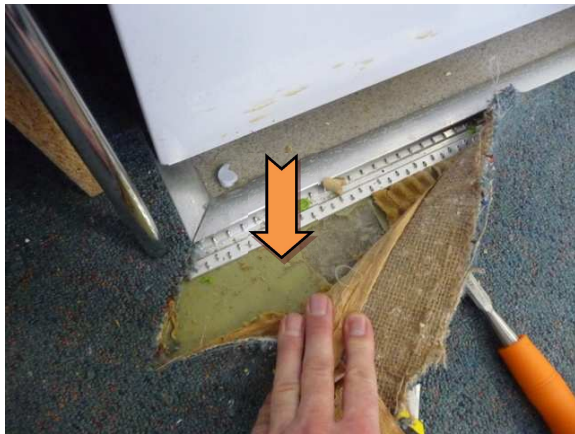
**Photo 15.** Contact Centre – under carpet – asbestos vinyl floor tiles – Sample 19952-001-004A.

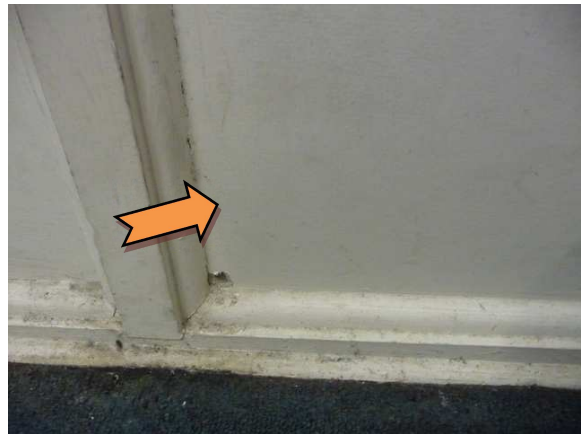
**Photo 16.** Contact Centre – east wall panels under windows – asbestos cement – Sample 19952-001-019.

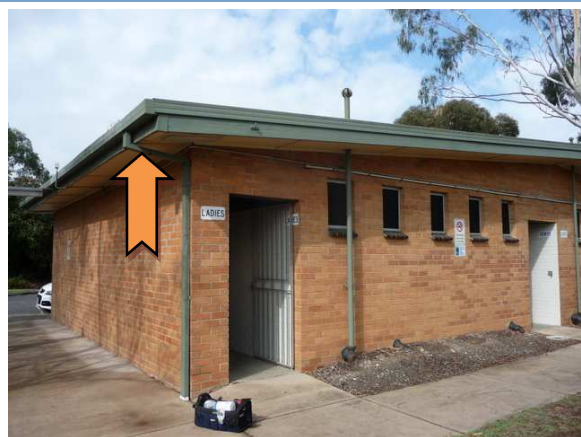
**Photo 18.** Contact Centre and Public Toilets – external eaves – asbestos cement. Sample 19952-001-009.

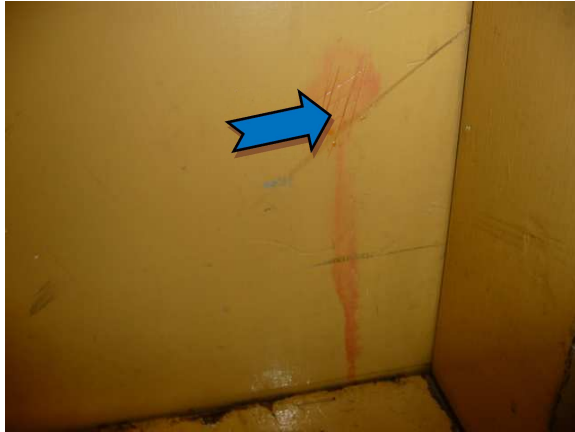
Lead-containing paint was identified on the first floor roof access doorway, as well as the white painted walls in the basement File Room 2 and the light blue walls and doorways of the Basement Print Room and Kitchen (Anderson Street Main Building). All paint coatings were in good condition.

**Photo 19.** Main Building 1<sup>st</sup> floor roof access point – doors and doorway – yellow lead-containing paint.

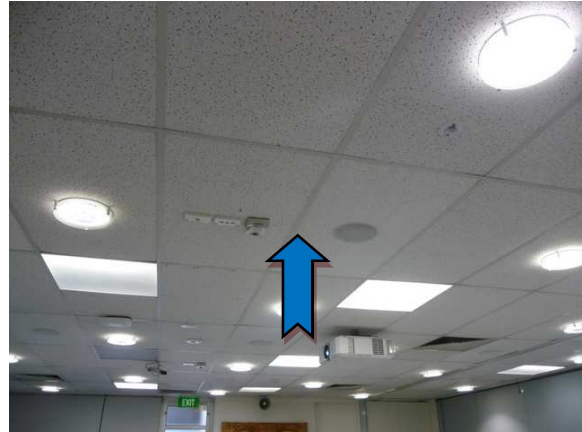
**Photo 20.** Main Building ground floor throughout – SMF ceiling tiles.

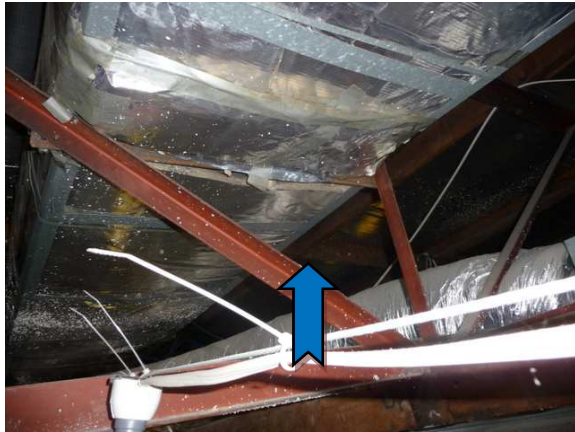
**Photo 21.** Main Building 1<sup>st</sup> floor ceiling space throughout – suspected SMF insulation in fixed air conditioner ductwork.
