INSPECTION REPORT

Work Order Number: 0024669	Site address of Tree: 3459 Warburton Highway WARBURTON VIC 3799	
Date of inspection: 19th January 2022 I have confirmed with the manager of Enspeg that the above date is wrong and that the correct date is 19th January 2023. Paul Mechelen 23-03-2023	Melway: 290 C4	
Name:	Address:	Phone:
Recommended action:		
<p>#1- Remove tree</p> <p style="text-align: center;">Reasons for recommended action:</p> <p>#1- The tree has co-dominant trunks with health and vigour that is typical for the species. The tree is stable in the ground with no evidence of any root plate instability. The tree is located in a gravel and asphalt carpark, and it is likely that ongoing minor compaction is affecting the root plate; however, no obvious deterioration to the health and vigour of the tree was noticed in the canopy at the time of the inspection.</p> <p>The primary union of the co-dominant trunks has split in the past on the north-western side from the top of the union (at approximately 1.7 metres) down to the basal area of the tree. Probing the split indicated substantial decay in the primary union and lower trunk of the tree. A small split in the primary union

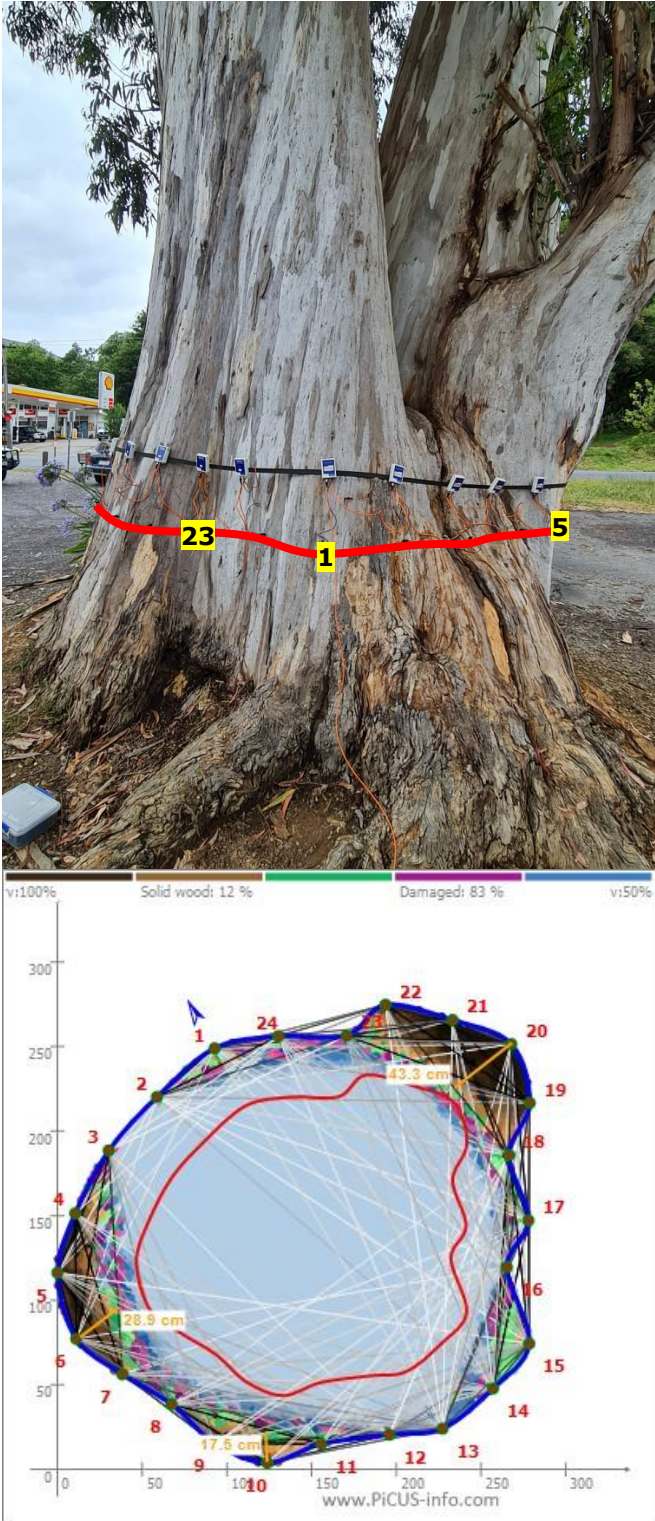
1 of 2 – Middle of primary union

The Sonic Tomograph test result indicates the percentage of the test area that is sound (high density) wood, incipient wood (wood being altered by the fungus) or active fungus and decayed (low density) wood. The tree was previously tested at approximately the same height in June 2016 and the results of that test, and the recent test are:

2016	2023
Sound wood	22%	12%
Incipient wood	9%	5%
Active fungus & decayed wood	69%	83%

The circumference of the trunk at the test height has increased by approximately 43 cm since the 2016 test, and it is acknowledged erosion of the soil at the base of the tree has lowered the ground level in the years between tests. Therefore, the current test height is lower on the trunk than the 2016 test.

Notwithstanding the change in test heights, comparing the two test results shows that the percentage of sound wood has decreased, and the percentage of active fungus and decayed wood has increased over the 6½ years since the last test in 2016.

The active fungus progressed further through the heartwood since the 2016 test causing extensive degradation to the structural integrity of the trunk at the test point. Additionally, the test result shows that the tension wood in the split primary union of the co-dominant trunks that traverses the test height from sensors 2-3 through to sensors 13-14 is totally dysfunctional.

The test result shows that there is some structural compression wood at the test height. At the test height, the test result shows at sensor 6 there is 28 cm of sound wood; at sensor 10 there is 17 cm of sound wood; and at sensor 20 there is 43 cm of sound wood. Furthermore, it is observed that new wood growth increments are occurring in the compression wood at sensors 5, 6, 19, 20, 21 and 22.

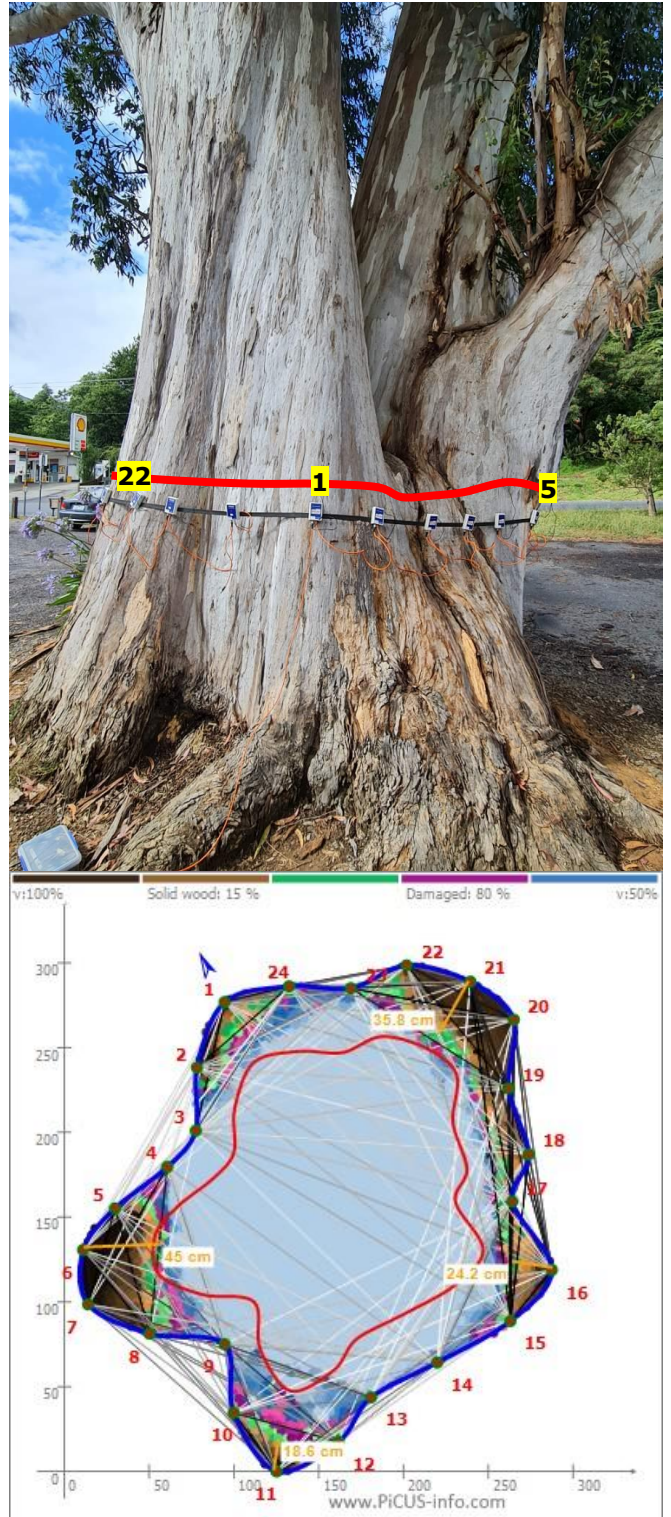
**2 of 2 – top section of the primary union
1500mm above ground level at sensor one
8700mm at test height**

The Sonic Tomograph test result indicates 15% of the test area is sound (high density) wood. There is 5% of incipient wood (wood being altered by the fungus). The remaining 80% is active fungus and decayed (low density) wood.

The fungus in the test result is associated with the degradation seen in the lower test point. The split primary union of the co-dominant trunks traverses the test height from sensors 3-4 through to sensor 14-15.

The active fungus has spread through the heartwood reaching the outer trunk between sensors 2 and 4; between sensors 8 and 10; between sensors 12 and 15; and between sensors 23 and 24. The test result shows that the fungus has caused significant degradation to the structural integrity of the trunk and primary union of the tree.

The progression of the fungus at the test point has confined the structural wood is to the compression wood of the co-dominant trunks and primary union. At the test height, the test result shows at sensor 6 there is 45 cm of sound wood; at sensor 11 there is 18 cm of sound wood; at sensor 16 there is 24 cm of sound wood; and at sensor 21 there is 35 cm of sound wood. Furthermore, it is observed that new wood growth increments are occurring in the compression wood at sensors 6, 7, 11, 20 and 21.

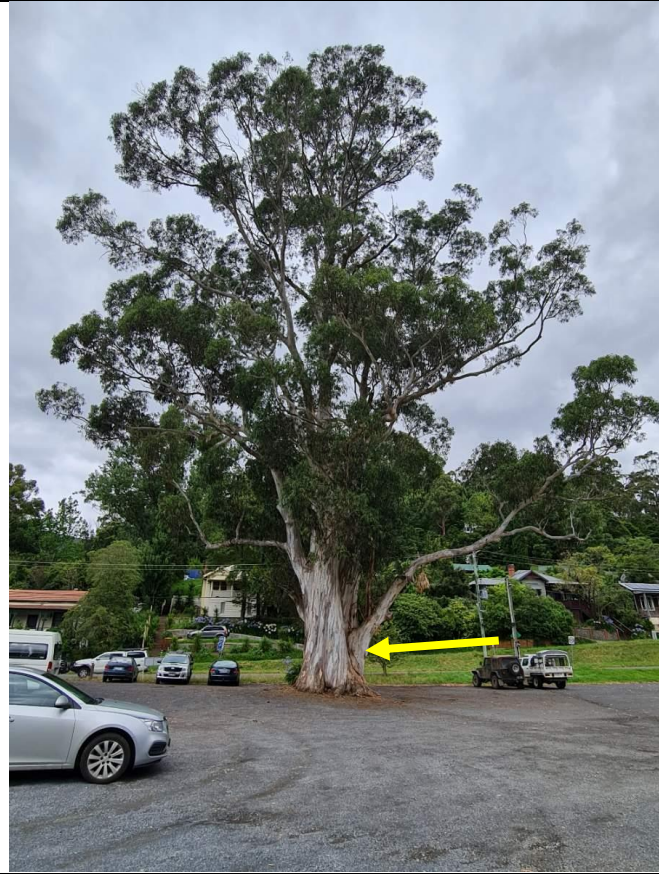
The tree in location

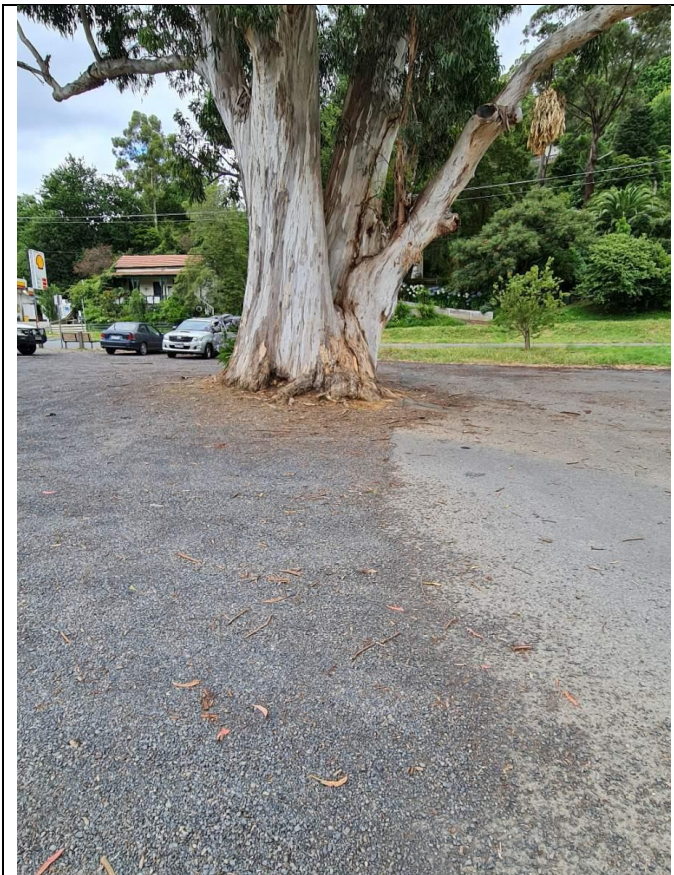
The gravel & asphalt carpark surrounding the tree

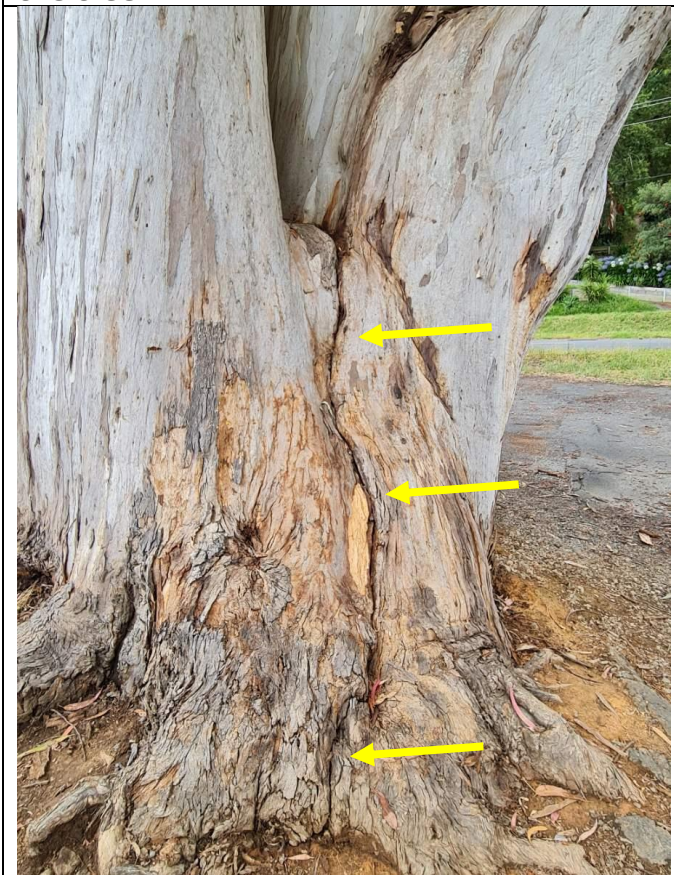
The split in the primary union on the north-western side of the union

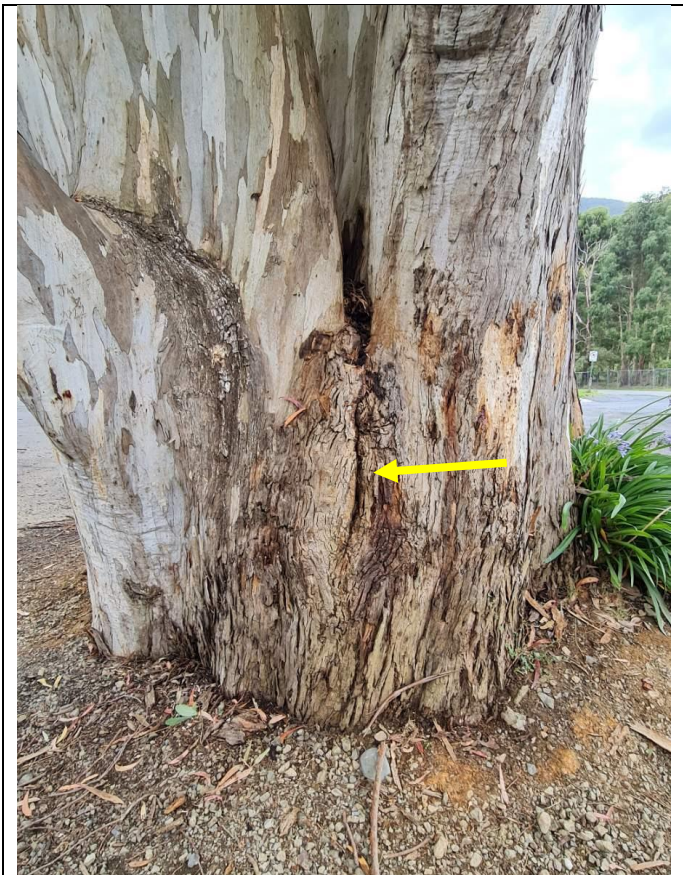
The smaller split in the south-eastern side of the primary union

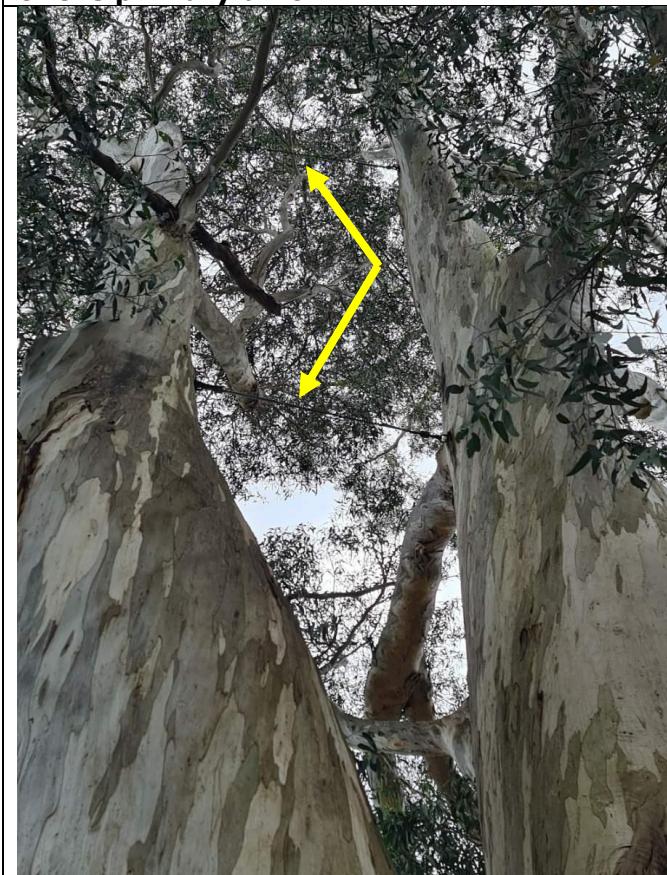
The cables previously installed between the co-dominant trunks.

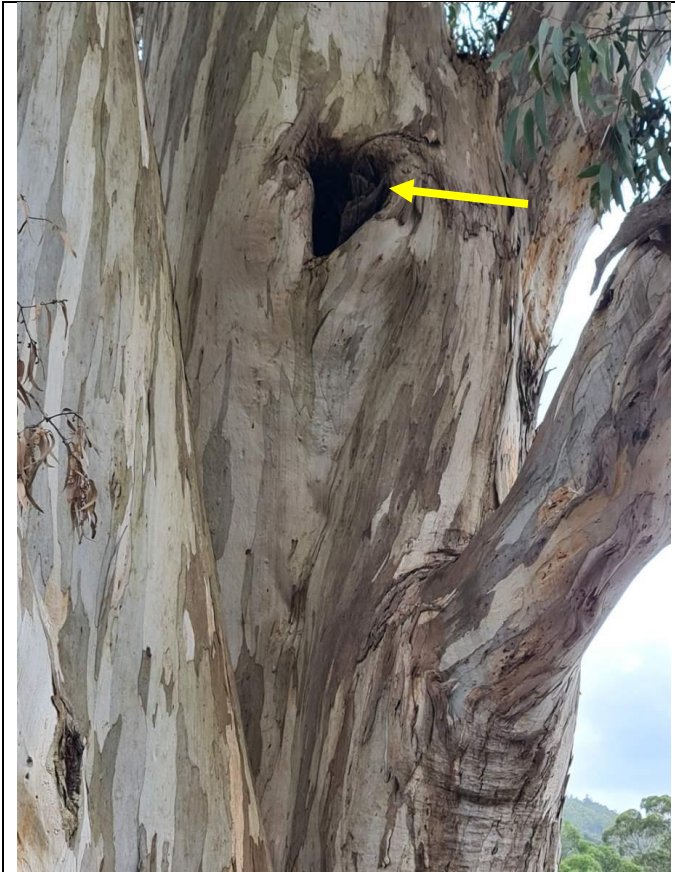
The hollow opening in the eastern co-dominant trunk

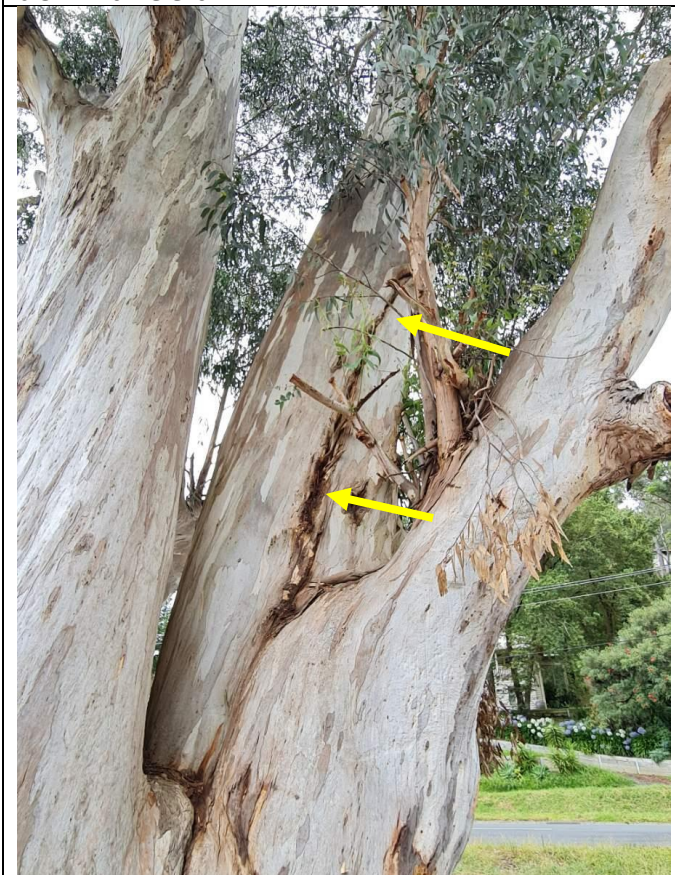
The lower part of the torsional split in the western trunk

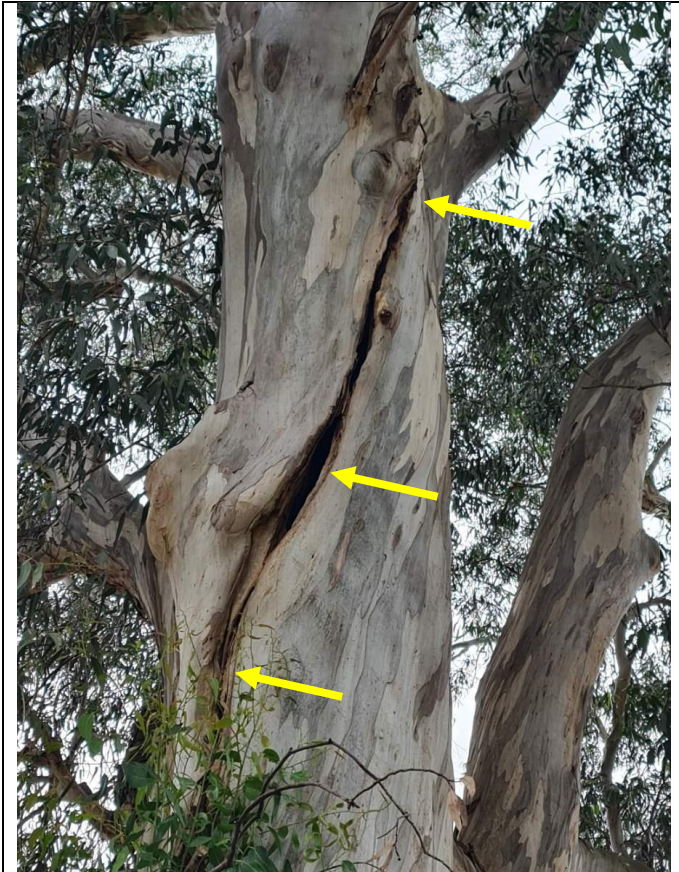
The upper part of the torsional split in the western trunk
