SHIRE OF YARRA RANGES
ADDITIONAL INSPECTION REPORT

REPORT NO.: CRTS 731725	INSPECTION TYPE: Climbing	DATE OF INSPECTION: 16/06/16
OBSERVATIONS: The tree is a large remnant Manna Gum situated in a public carpark and presents in fair to good health. A limb in the lower canopy appears to have failed recently and a normal amount of major deadwood is present. The tree bifurcates at approximately ground level with an active split present on the eastern side of the union. The opposite side of the split did not appear to be opening on the day of the inspection. A 2 tonne cobra brace is present approximately mid canopy to support this bifurcated union at the base. The brace is weathered & taut with no expansion loop present at the southern termination. A wound is present approximately 2 metres up the main stem with significant decay extending down toward the bifurcated union.		
COMMENTS / RECOMMENDATIONS: The decay present in the main stem, particularly at the site of the bifurcation, needs to be explored further via a Picus test to determine its extent and whether it is viable to retain the tree. The current brace is inadequate to support the size/weight of the leader. It appears to have

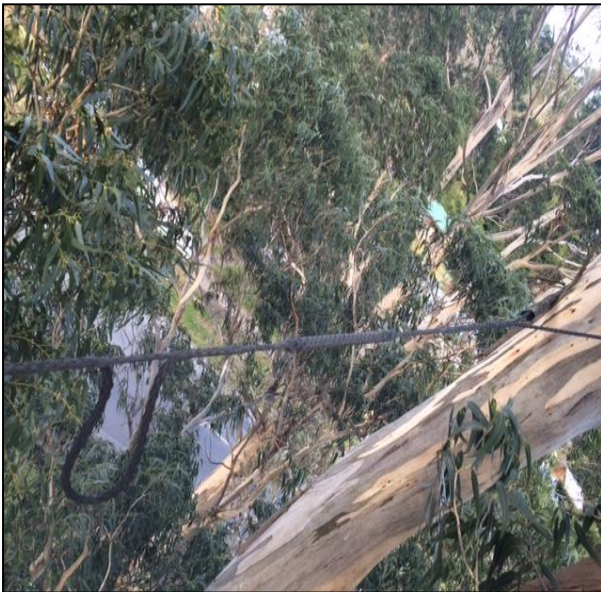
Existing brace with no expansion loop at the southern termination

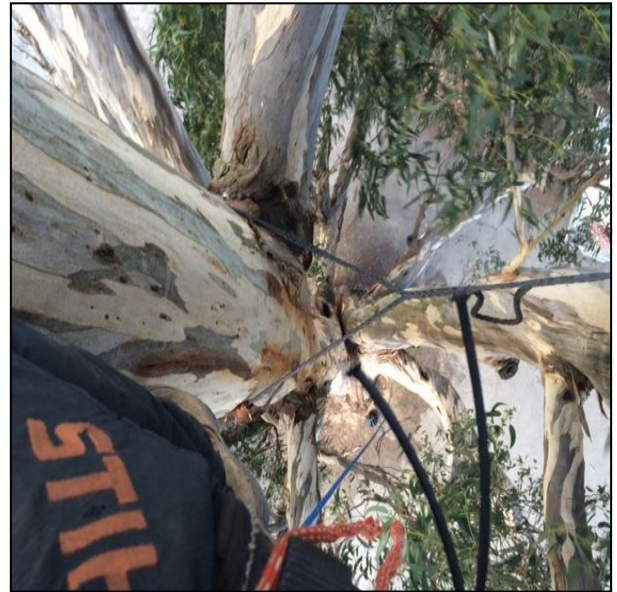
Looking down on the union to being supported

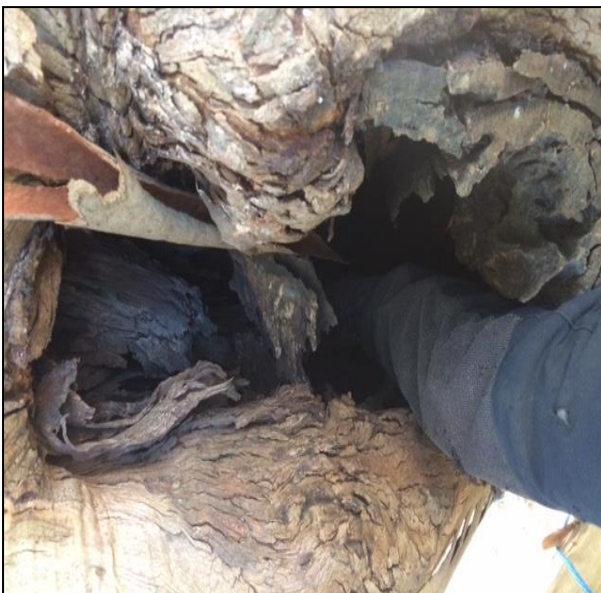
Large wound present in main trunk with decay extending down toward bifurcated union

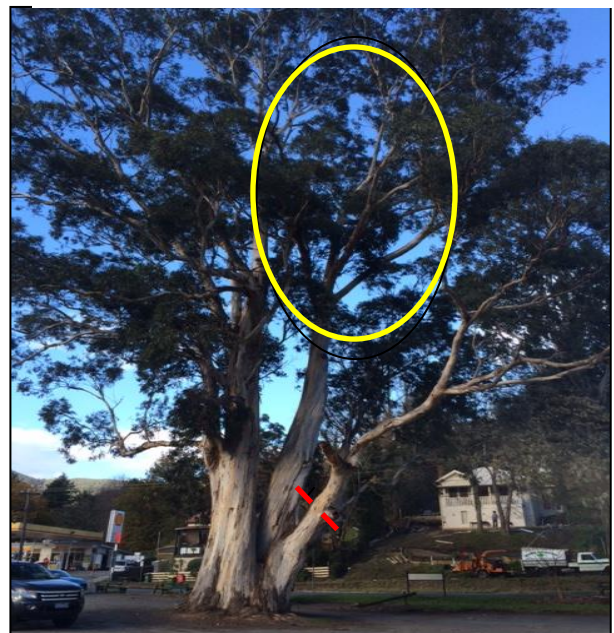
Overview of tree highlighting southern leader that needs weight reduction, red line indicates limb to be removed
