Habitat Tree Feasibility Assessment

Mountain Grey Gum
(*Eucalyptus cypellocarpa*)

3459 Warburton Highway
Warburton, VIC 3799

3rd of April 2023

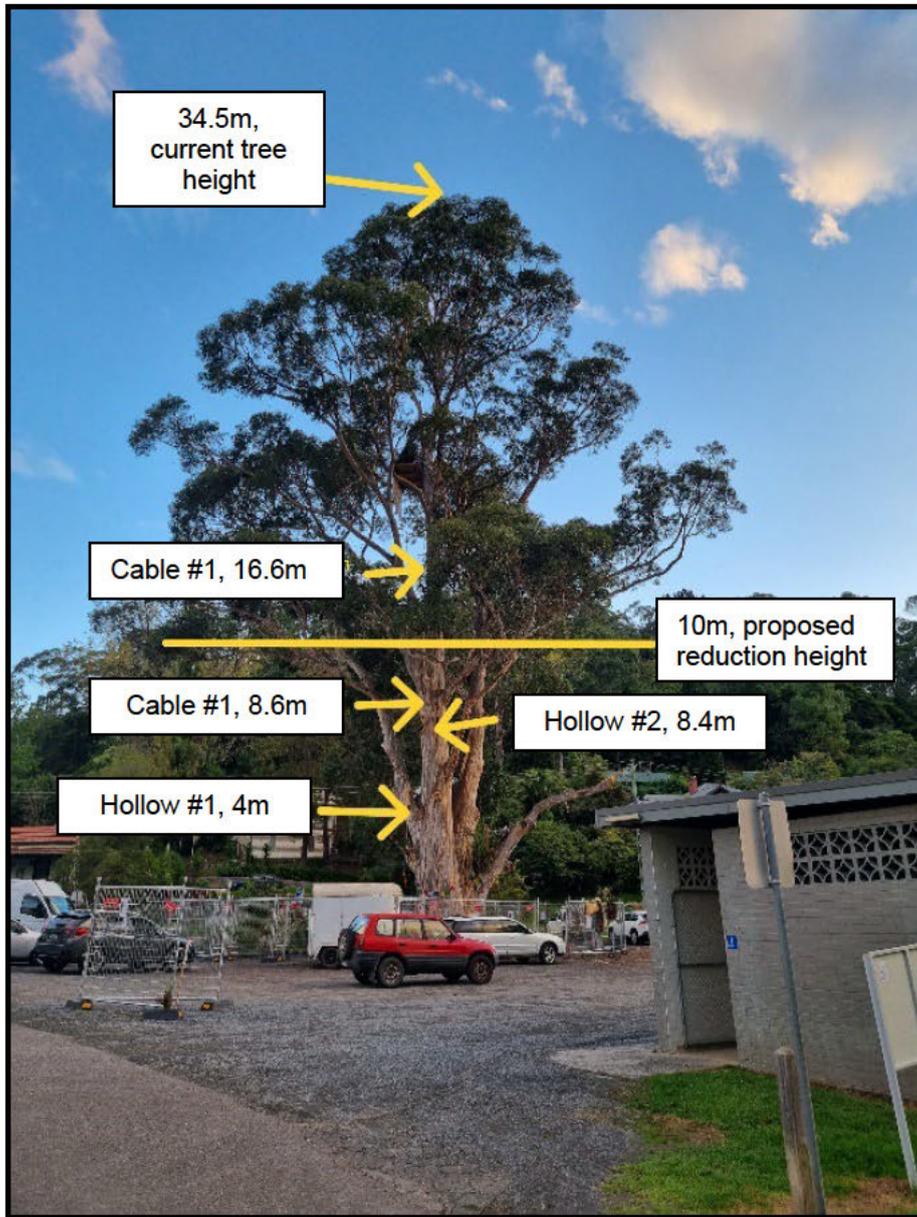
- There are two (2) natural hollows within the tree, at 4.0m (hollow #1) and at 8.4m (hollow #2) above ground level and a large crevice in the trunk.
- A pre-clear fauna survey was undertaken by a zoologist on the 22nd of March 2023, with the use of a remote-controlled extendable pole camera. Both hollows were found to be unoccupied but are suitable for use by native fauna.

- Two (2) steel cables have been installed in the canopy, one at 8.6m (cable #1) and one at 16.6m (cable #2) above ground level.

Figure 1: Showing the position of hollows and cables in tree #1.

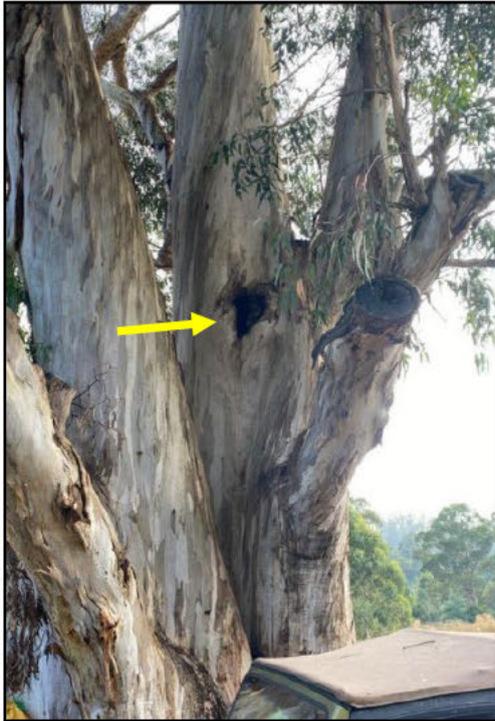
Figure 2: Showing Hollow #1 on the south side of the tree

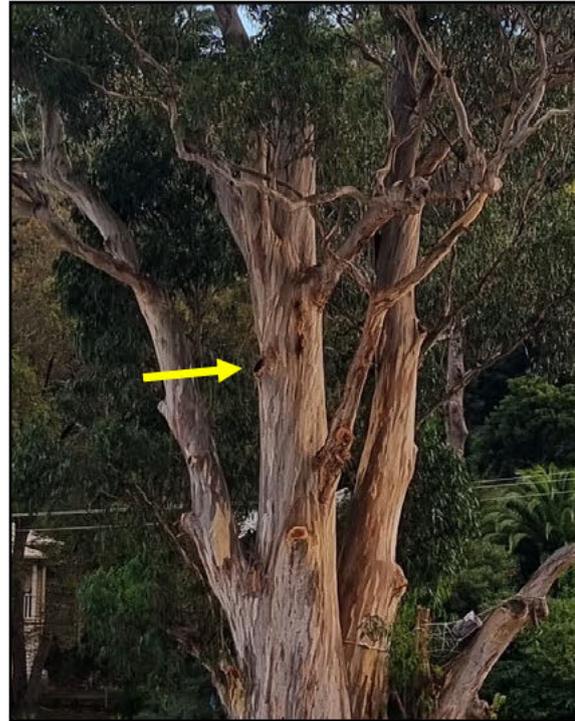
Figure 3: Showing Hollow #2 on the north side of the tree

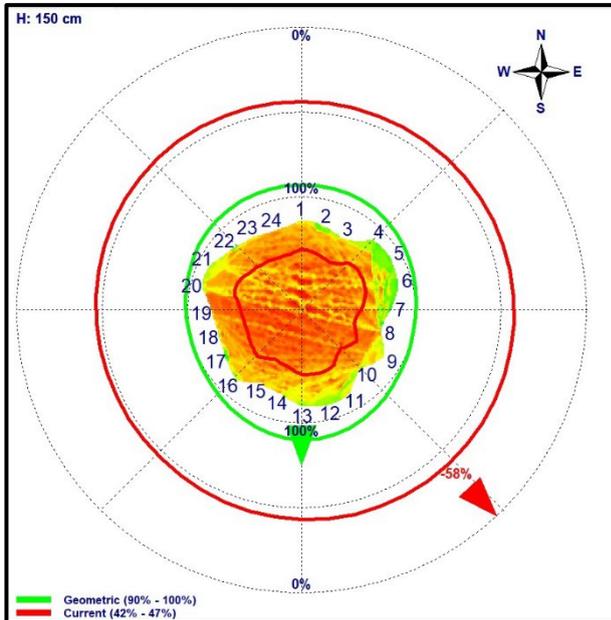
- Two (2) sonic tomographs were undertaken at 1m and 1.5m above ground level. Both showed significant decay is present in the lower trunk. This aligns with the sonic tomograph testing undertaken by ENSPEC on the 9th of January 2022.

Figure 4: Showing sonic tomograph conducted on 28/03/2023 at 1.5m from ground level. Showing 58% strength loss to the south-east

- The sonic tomograph shows a 58% strength loss to the southeast of the tree.
- There is very little sound wood tissue measured around the edges of the trunk.
- There is interference in the reading as a result of the crack in the middle of the trunk, which has resulted in a partial distortion of the image (striping).

- Reduce the tree's height to 10m.
- Prior to reduction pruning the upper canopy must be inspected by a zoologist to determine if nature fauna is present and undertake the mitigation measures if required.

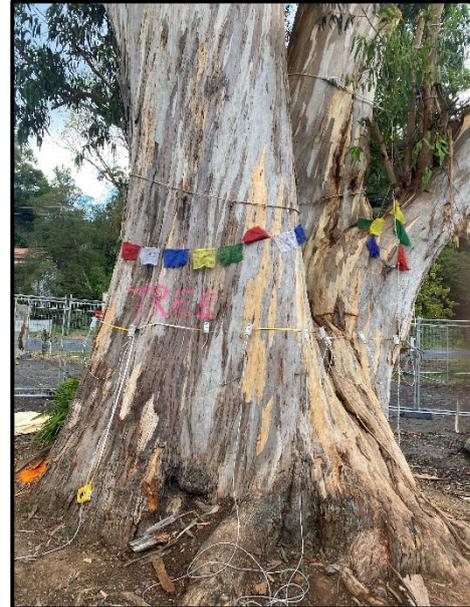
Figure 5: Showing sensors on the lower trunk at 1.5m above ground level. 28/03/2023.

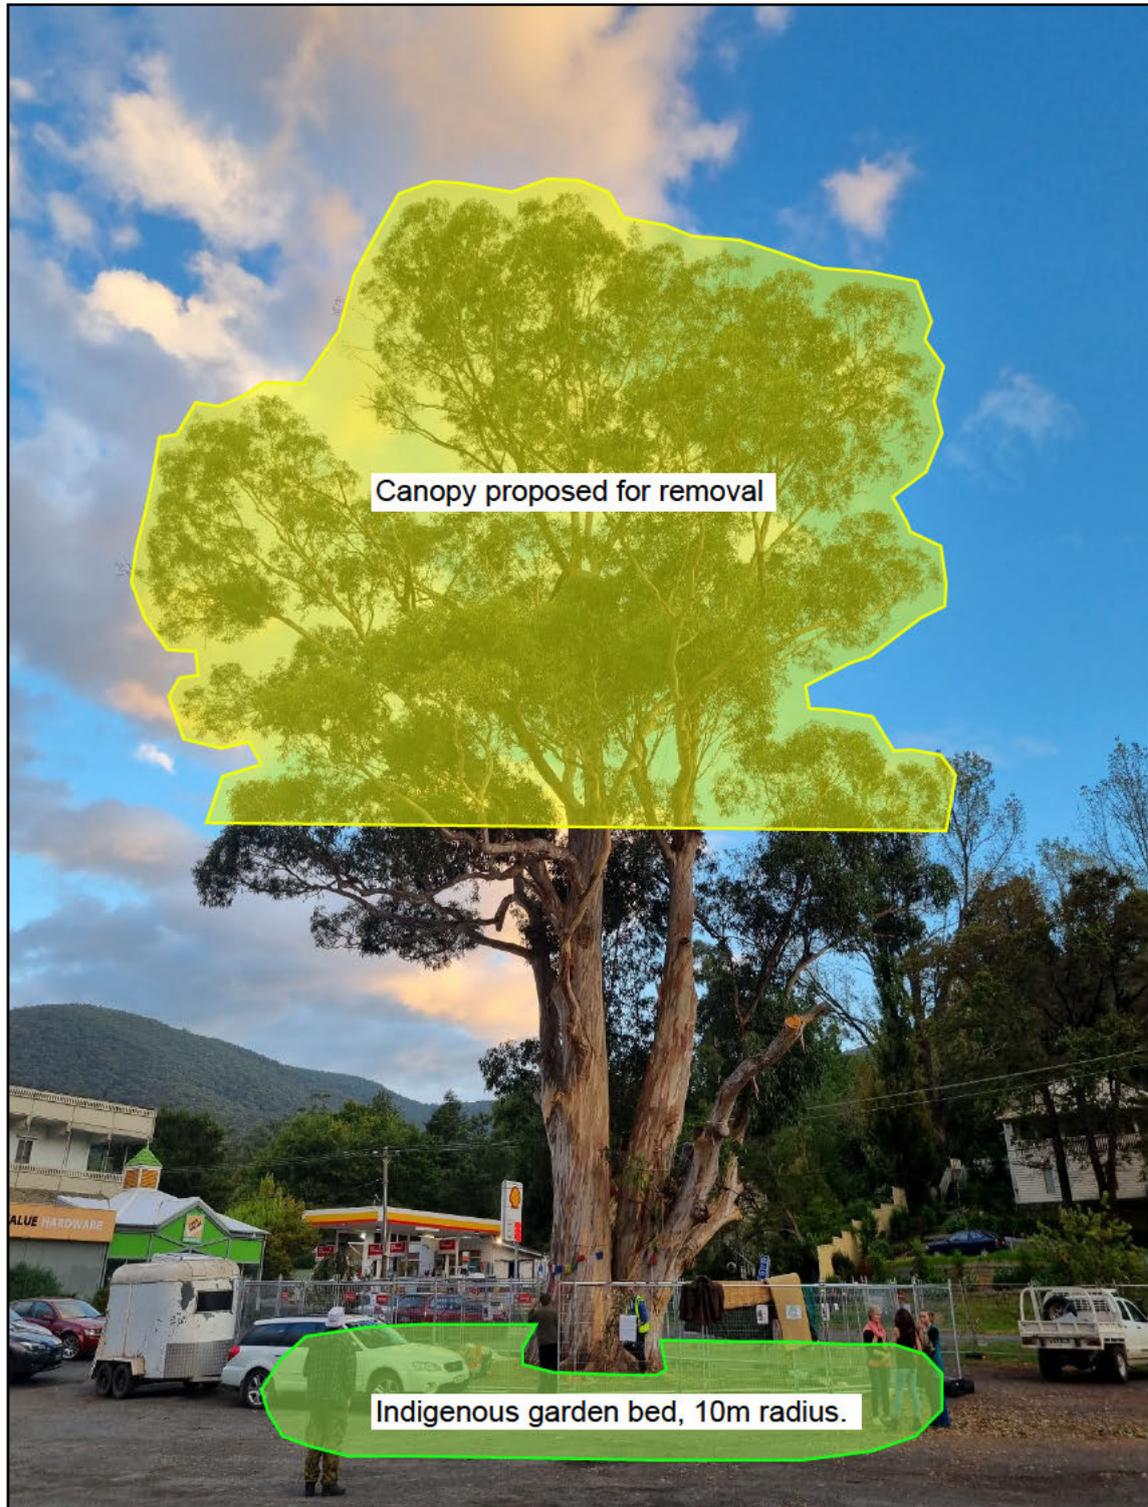
Figure 7: Showing proposed habitat works and passive exclusion zone.

- Plant a native garden bed around the tree's base, encouraging more fauna presence and acting as a passive exclusion zone.
- To minimise root damage, arborist supervision is required for the removal of the existing carpark within the footprint of the proposed garden bed.

- Underplanting the trunk with indigenous understorey trees and large shrubs typical of EVC 29 *Damp Forest* in the Highlands – Southern Fall bioregion or Yarra Ranges Council plant communities 07 *Mountain Grey Gum Damp Forest – Central Highlands*.

- Quick-growing tree understorey trees such as Silver Wattle (*Acacia dealbata*) would provide a canopy to shade the trunk hollows (Figure 7).
- The use of prickly shrubs such as Hedge-wattle (*Acacia paradoxa*) and Sweet Bursaria (*Bursaria spinosa*) would discourage the use of the garden bed by people and provide habitat for small passerines (songbirds).
