INSPECTION REPORT

Work Order Number: 0024669	Site address of Tree: 3459 Warburton Highway WARBURTON VIC 3799	
Date of inspection: 19th January 2022 Correct date is 19 th January 2023 amended by SB	Melway: 290 C4	
Name: [REDACTED]	Address: [REDACTED]	Phone: [REDACTED]
Recommended action:		
<p>#1- Remove tree</p> <p style="text-align: center;">Reasons for recommended action:</p> <p>#1- The tree has co-dominant trunks with health and vigour that is typical for the species. The tree is stable in the ground with no evidence of any root plate instability. The tree is located in a gravel and asphalt carpark, and it is likely that ongoing minor compaction is affecting the root plate; however, no obvious deterioration to the health and vigour of the tree was noticed in the canopy at the time of the inspection.</p> <p>The primary union of the co-dominant trunks has split in the past on the north-western side from the top of the union (at approximately 1.7 metres) down to the basal area of the tree. Probing the split indicated substantial decay in the primary union and lower trunk of the tree. A small split in the primary union was also observed on the south-eastern side of the primary union

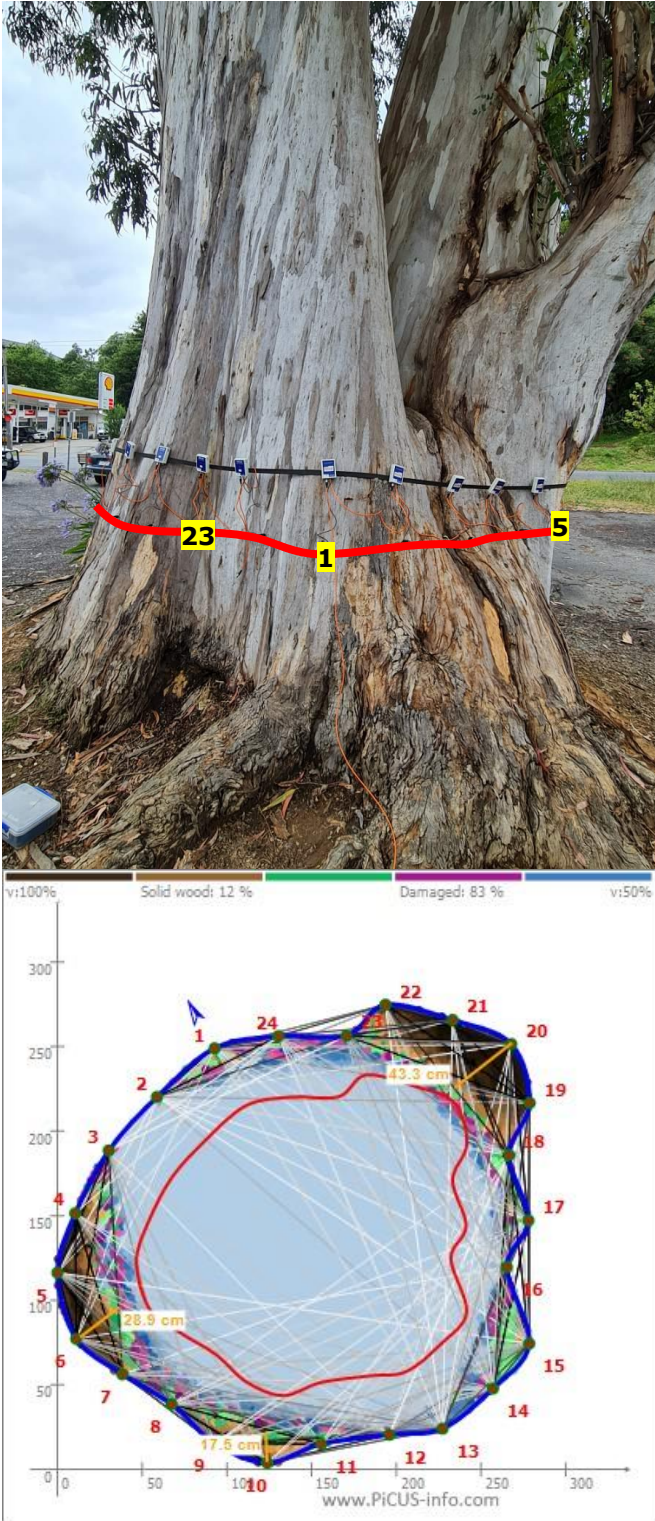
Carpark
1
1 of 2 – Middle of primary union
Eucalyptus cypellocarpa
Mountain Grey Gum
1000mm above ground level at sensor one
8630mm at test height

The Sonic Tomograph test result indicates the percentage of the test area that is sound (high density) wood, incipient wood (wood being altered by the fungus) or active fungus and decayed (low density) wood. The tree was previously tested at approximately the same height in June 2016 and the results of that test, and the recent test are:

2016	2023
Sound wood	22%	12%
Incipient wood	9%	5%
Active fungus & decayed wood	69%	83%

The circumference of the trunk at the test height has increased by approximately 43 cm since the 2016 test, and it is acknowledged erosion of the soil at the base of the tree has lowered the ground level in the years between tests. Therefore, the current test height is lower on the trunk than the 2016 test.

Notwithstanding the change in test heights, comparing the two test results shows that the percentage of sound wood has decreased, and the percentage of active fungus and decayed wood has increased over the 6½ years since the last test in 2016.

The active fungus progressed further through the heartwood since the 2016 test causing extensive degradation to the structural integrity of the trunk at the test point. Additionally, the test result shows that the tension wood in the split primary union of the co-dominant trunks that traverses the test height from sensors 2-3 through to sensors 13-14 is totally dysfunctional.

The test result shows that there is some structural compression wood at the test height. At the test height, the test result shows at sensor 6 there is 28 cm of sound wood; at sensor 10 there is 17 cm of sound wood; and at sensor 20 there is 43 cm of sound wood. Furthermore, it is observed that new wood growth increments are occurring in the compression wood at sensors 5, 6, 19, 20, 21 and 22.

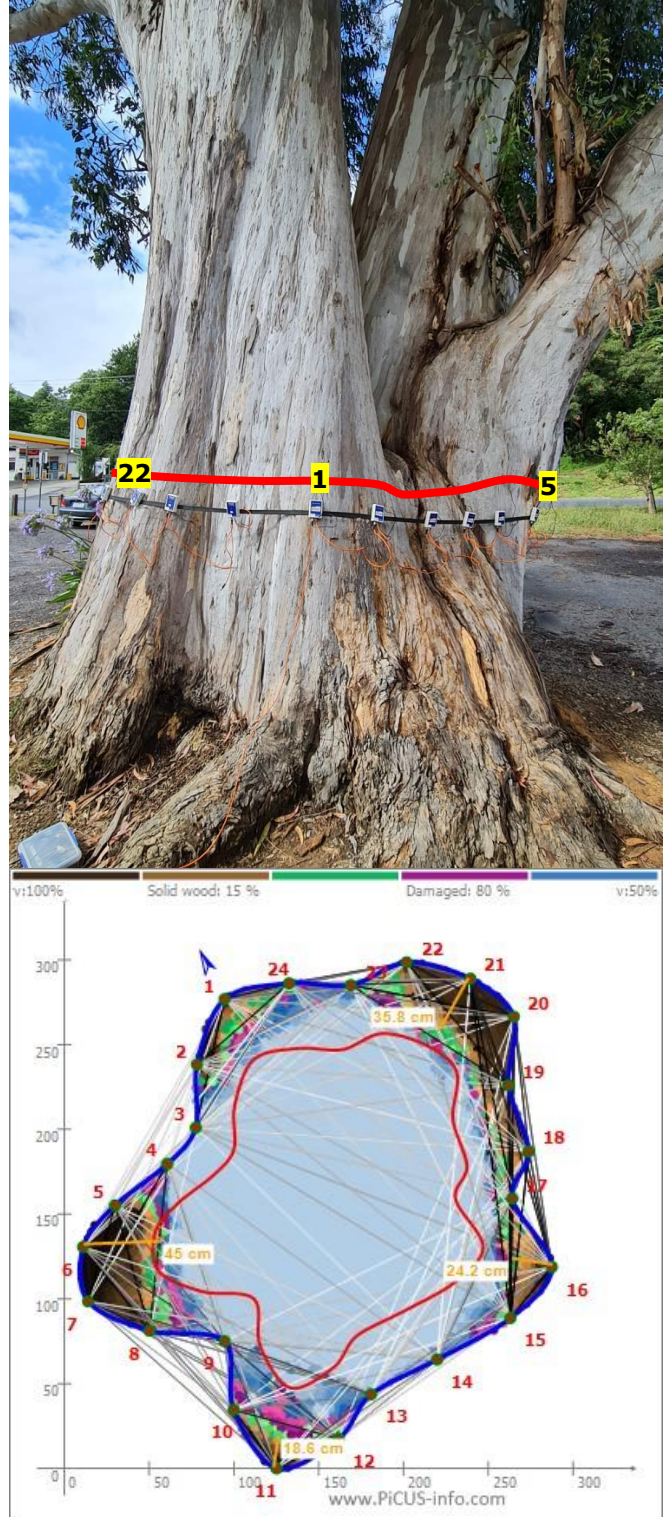
**2 of 2 – top section of the primary union
1500mm above ground level at sensor one
8700mm at test height**

The Sonic Tomograph test result indicates 15% of the test area is sound (high density) wood. There is 5% of incipient wood (wood being altered by the fungus). The remaining 80% is active fungus and decayed (low density) wood.

The fungus in the test result is associated with the degradation seen in the lower test point. The split primary union of the co-dominant trunks traverses the test height from sensors 3-4 through to sensor 14-15.

The active fungus has spread through the heartwood reaching the outer trunk between sensors 2 and 4; between sensors 8 and 10; between sensors 12 and 15; and between sensors 23 and 24. The test result shows that the fungus has caused significant degradation to the structural integrity of the trunk and primary union of the tree.

The progression of the fungus at the test point has confined the structural wood is to the compression wood of the co-dominant trunks and primary union. At the test height, the test result shows at sensor 6 there is 45 cm of sound wood; at sensor 11 there is 18 cm of sound wood; at sensor 16 there is 24 cm of sound wood; and at sensor 21 there is 35 cm of sound wood. Furthermore, it is observed that new wood growth increments are occurring in the compression wood at sensors 6, 7, 11, 20 and 21.

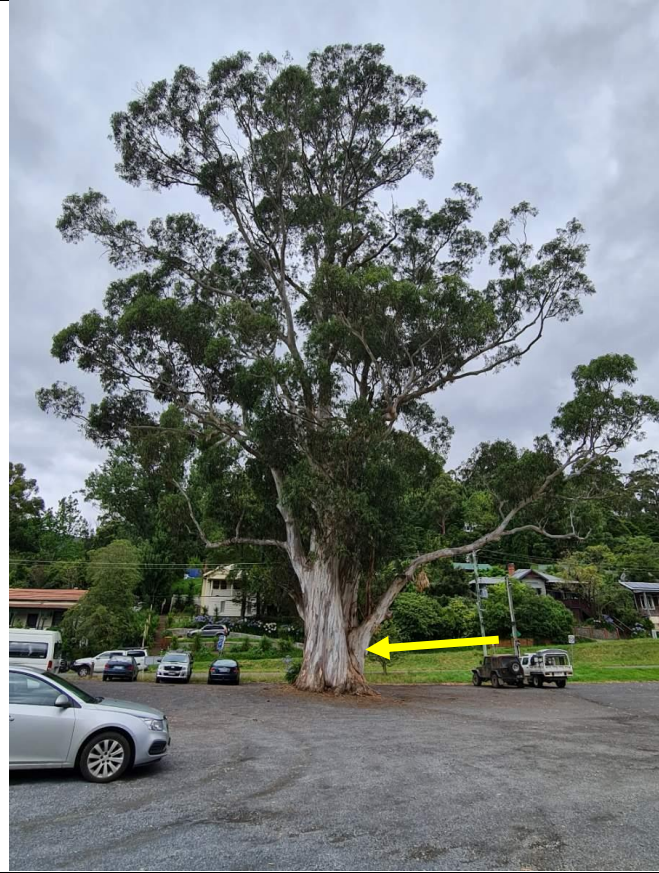
The tree in location

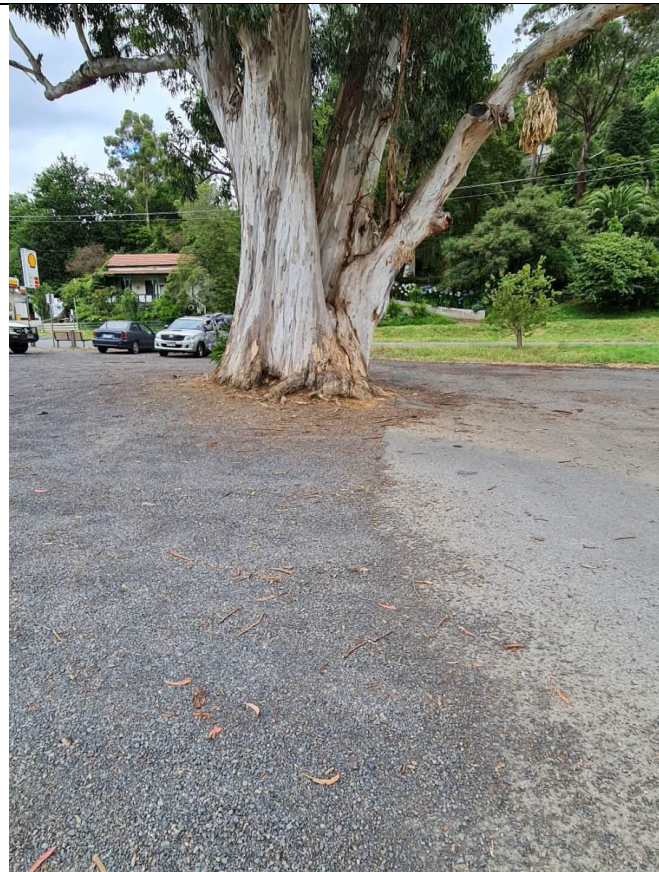
The gravel & asphalt carpark surrounding the tree

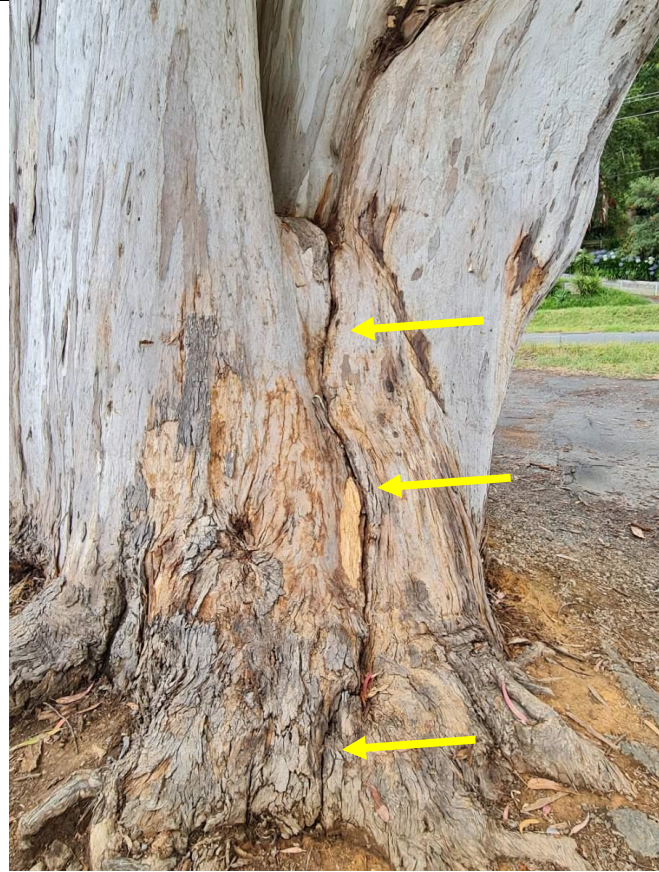
The split in the primary union on the north-western side of the union

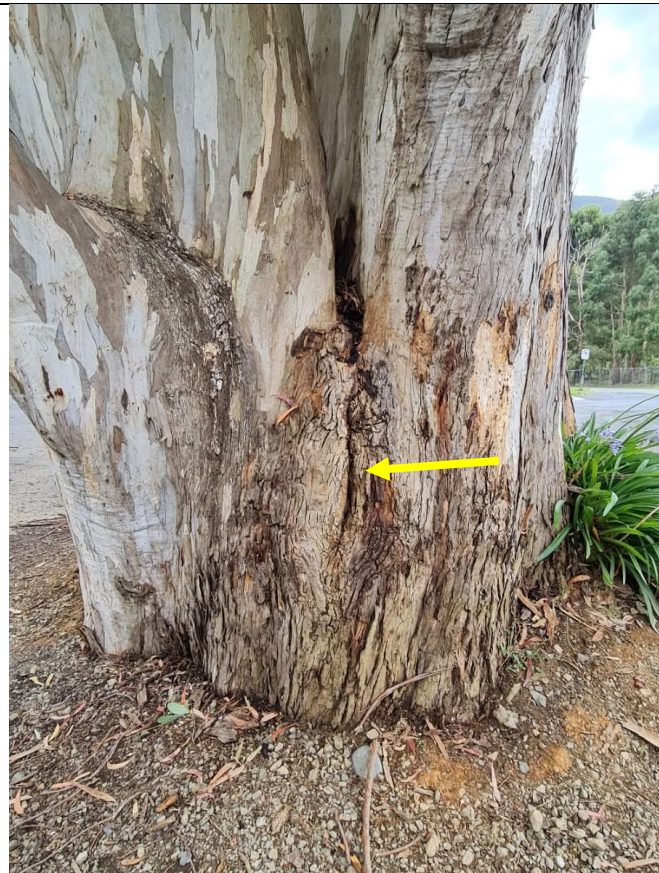
The smaller split in the south-eastern side of the primary union

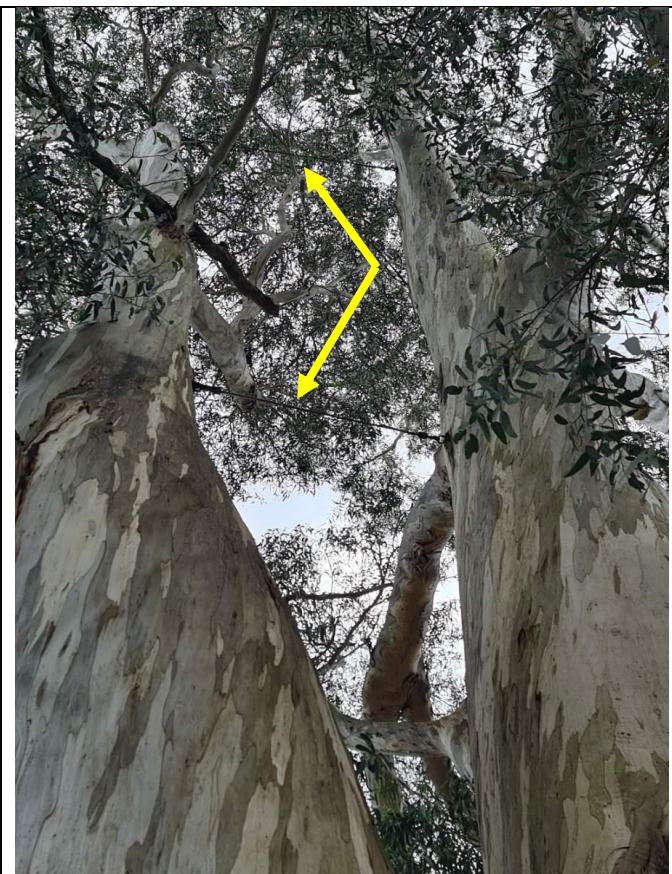
The cables previously installed between the co-dominant trunks.

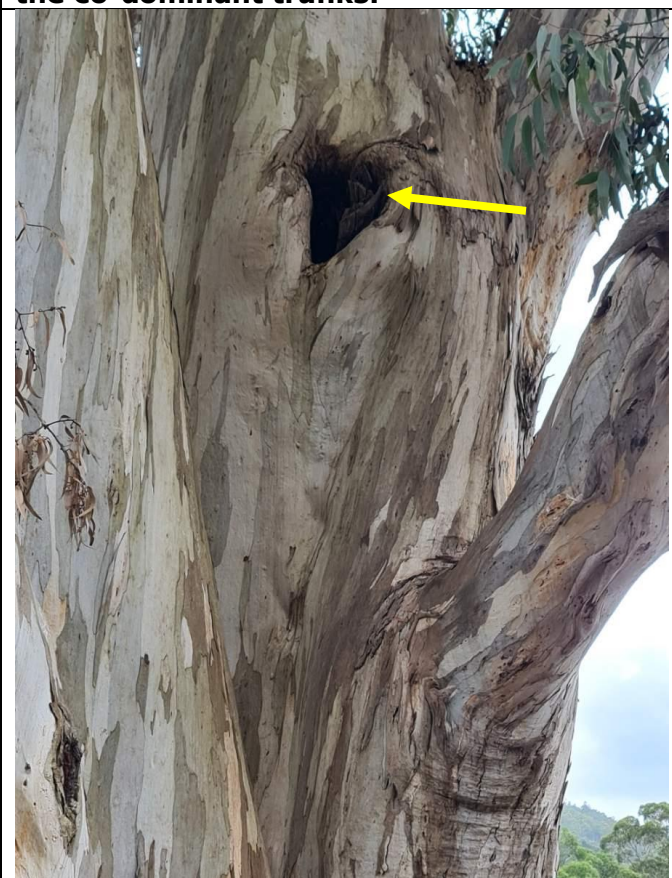
The hollow opening in the eastern co-dominant trunk

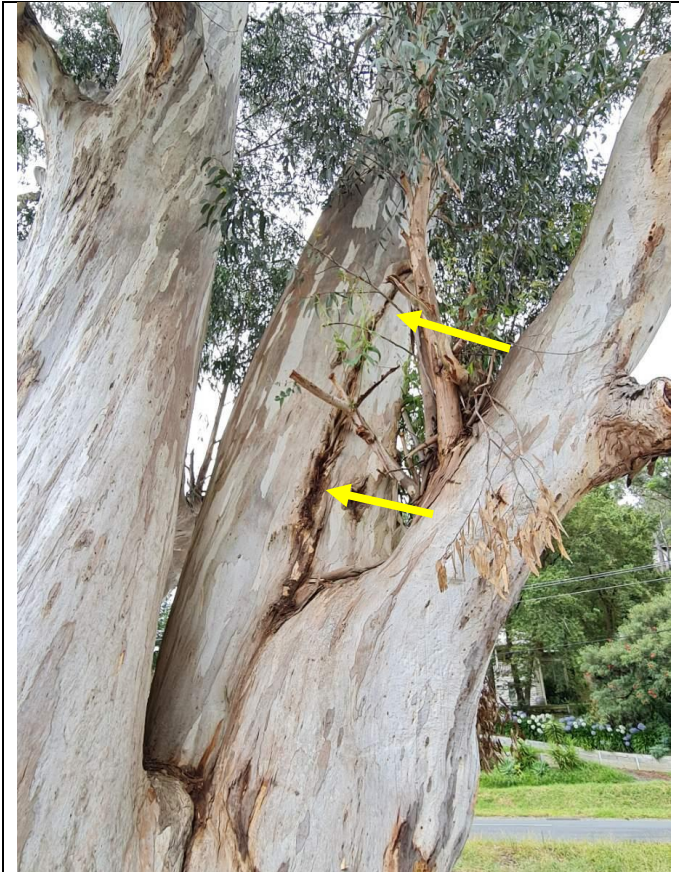
The lower part of the torsional split in the western trunk

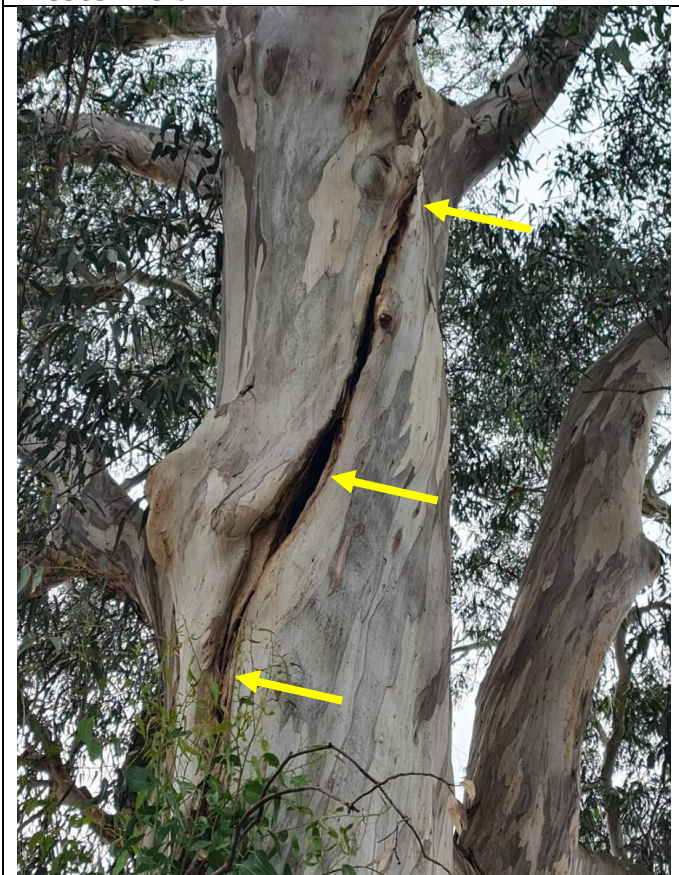
The upper part of the torsional split in the western trunk
