PICUS SONIC TOMOGRAPH TEST (ST) SUMMARY REPORT.

YARRA RANGES COUNCIL

731725

LOCATION: 3457A WARBURTON HIGHWAY, WARBURTON VIC 3799

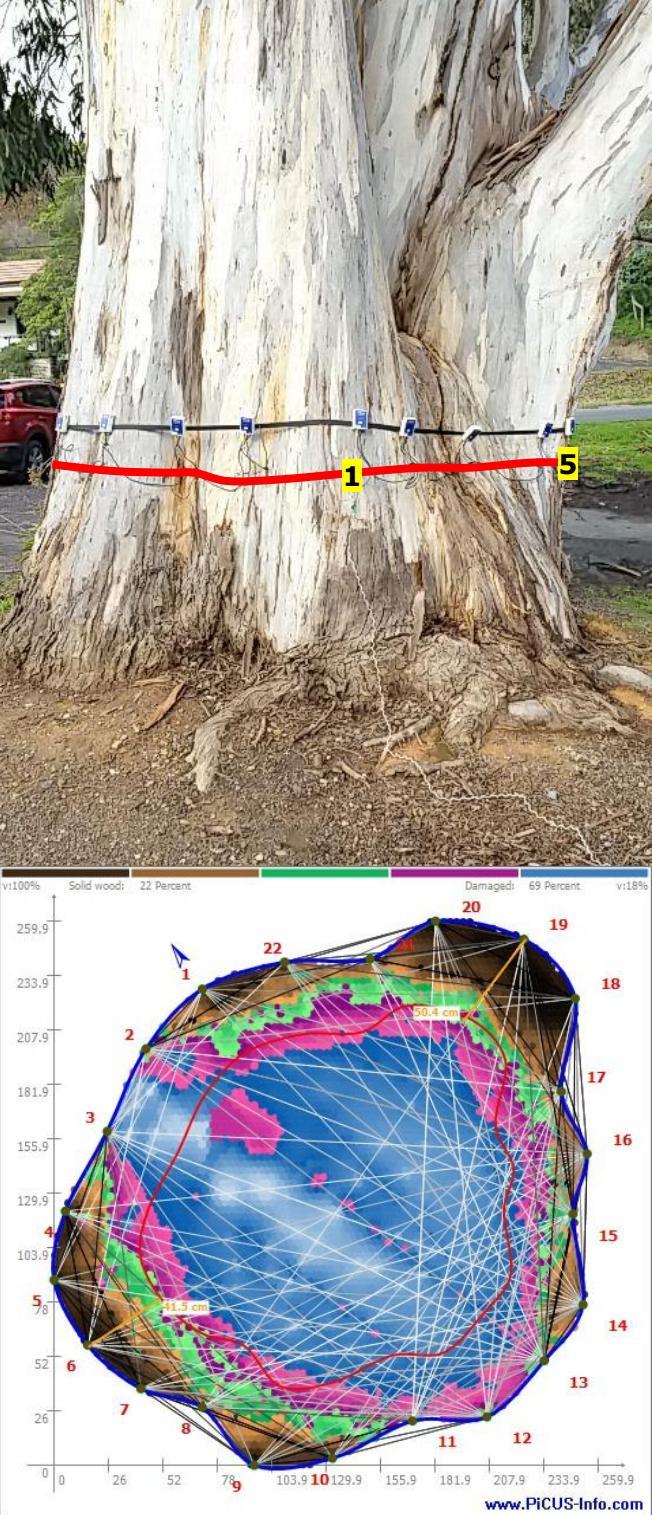
The PiCUS© Sonic Tomograph test result indicates 22% of the test area is sound (high density) wood. There is 9% of incipient wood (wood being altered by the fungus). The remaining 69% is active fungus and decayed (low density) wood.

When evaluating the test results and checking with additional filters (i.e. algorithms) it was established that the incipient wood has a similar wood density to the sound wood. Therefore the incipient wood has been categorised as sound wood in these test results which gives a total of approximately 31% of sound structural wood.

The tree has co-dominant trunks with the union traversing the test height from sensors 2-3 through to sensors 12-13. The union has split open and a nylon cable was observed in the canopy between the co-dominant trunks.

The fungus in the test result has entered the tree through the union of the co-dominant trunks. The active fungus has spread along the main union and the active fungus and decay has contributed to the split in the union. This degradation to the tension wood in the main union is a concern as a complete failure of the union could occur in a wind event.

The test result shows that there is structural wood in the compression wood of the main union. At the test height there is 41cm of sound wood and incipient wood at sensor 6; and 50cm of sound wood and incipient wood at sensor 19. Additionally, it is observed that new wood growth increments are occurring at sensors 1, 4, 5, 6, 7, 9, 18, 19 and 20.

The test provides evidence that there is substantial decay in the union of the co-dominant trunks at the test height. This decay has caused significant degradation to the structural integrity of the union.

- Three steel threaded bolts should be installed at the union of the co-dominant trunks to provide bracing for the union.
- The nylon rope cable in the tree should be removed and a steel cable be installed between the co-dominant trunks.

Provided that the recommendations are undertaken, the tree has an estimated useful life expectancy of up to 20 plus years at the test points. It is also recommended that this tree is retested in 24 months to assess the progression of the fungus and re-evaluate the structural integrity of the trunk at the test height.
