# Detailed Site Investigation 15 Anderson Street Lilydale VIC 3140

Yarra Ranges Council 16 May 2016 Final

Prensa Pty Ltd (Prensa) was engaged by Yarra Ranges Council (Council) to conduct a Detailed Site Investigation (DSI) of the property located at 15 Anderson Street, Lilydale Victoria (the Site).

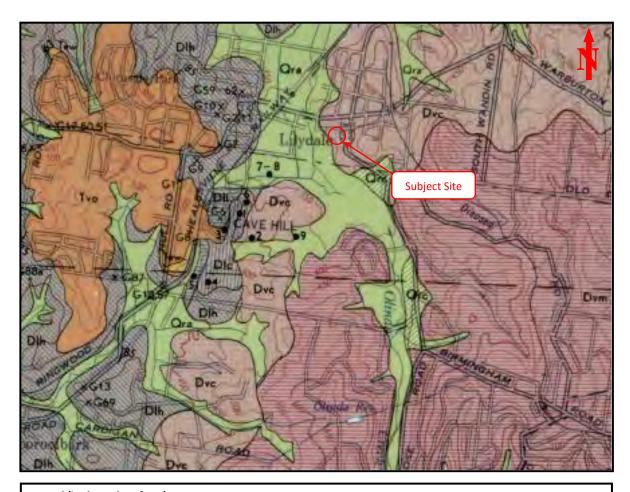
The Quaternary age alluvial deposits are underlain at relatively shallow depth by the Coldstream Rhyolite. The Coldstream Rhyolite extends to depths in excess of those likely to be influenced by the proposed development.

An extract from the Geological Survey of Victoria, 1:63,360 series, Ringwood sheet is provided in Figure 1.4.1.

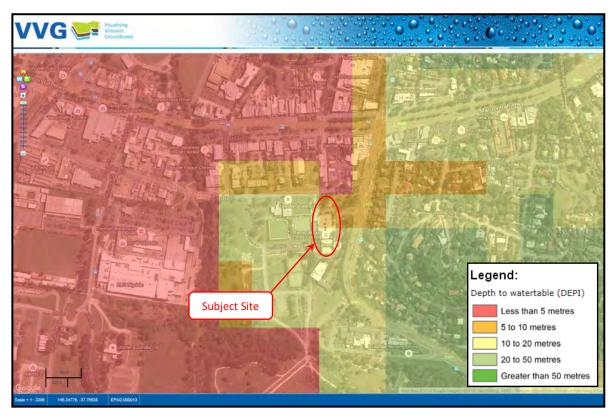
FIGURE 1.5.1: Screenshot from the Visualising Victoria's Groundwater Website.

Reference to Visualising Victoria's Groundwater website ( $\frac{\text{http://maps.ubspatial.com.au/vvg}}{\text{volume}}$ ) indicates the depth of the ground water table to be 5-10 metres below the ground surface at the subject site.

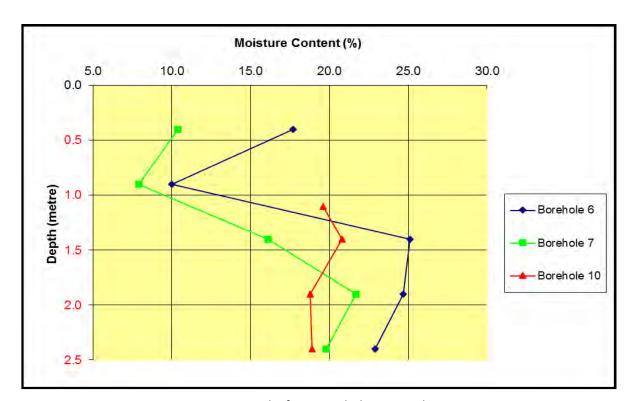
FIGURE 3.4.1: Moisture Content Test Results from Boreholes 6, 7 and 10

The moisture content tests indicate variable moisture content levels within the clay profile underlying the subject site both laterally between the boreholes and vertically within each of the boreholes.

The laboratory test results are given in Appendix D of this report. A summary of the test results is provided in Figure 3.4.1 and Tables 3.4.1 and 3.4.2.

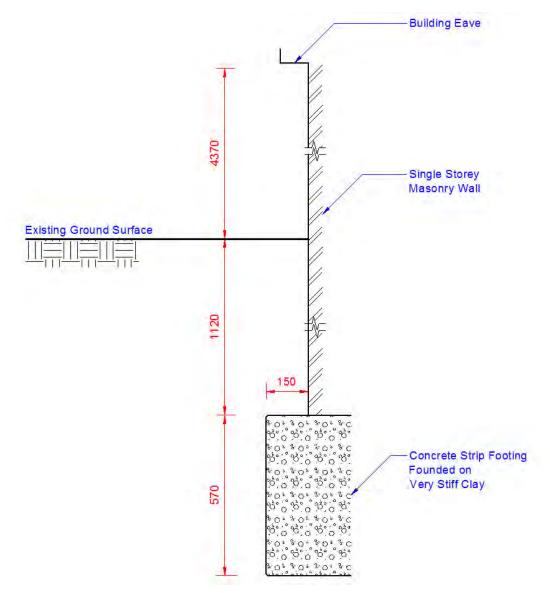
FIGURE 3.5.1: Summary of Existing Footing Geometry and Founding Conditions at Test Location 7

Figure 3.5.1 provides a summary of the footing geometry and founding conditions of the footing which provides support to the perimeter wall of the existing library building at the subject site, as exposed at Test Location 7.

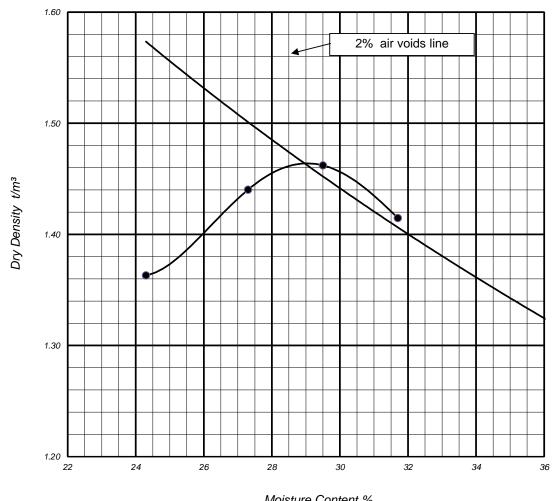
**Contact Name:** Madeleine Parris

### DRY DENSITY - MOISTURE CONTENT PLOT

Calculated apparent particle density =  $2.63 \ t/m^3$
