Review of Stage 1b Lilydale Heritage Review Gap Study Lilydale Heritage Study (Task 2)

Prepared for Yarra Ranges Council

November 2021—Final

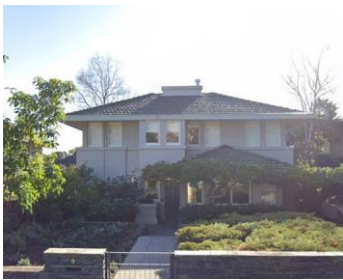
<p>Figure 7. Revell (source: Google Streetview, 2019)</p>

<p>Figure 6. Dr Jorgensens House and Studio (source: Google Streetview, 2019).</p>
	<p>Revell, 9 Toorak Avenue, Toorak (HO342 City of Stonnington)</p> <p>This 1920 Edward F. Bilson designed house is analogous to Wiori in terms of form and style. Although it is a more articulated example of Prairie-style architecture, its defining features are similarly observable at Wiori through the shallow pitched hipped roof with</p>

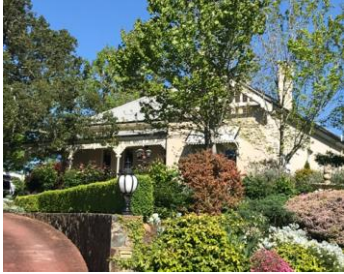
<p>Figure 11. Willowbank (source: Extent Heritage, 2021).</p>
Part 1B Lilydale Heritage Review Gap Study 2019 comments	<p>Trevor Westmore: <i>This is a considerably extended Edwardian hip and gable brick dwelling with a corrugated iron roof, the street elevation of which is essentially intact. It may have been over-rendered, but this probably would not disqualify it from significance at the local level.</i></p> <p><u>Recommendation:</u> Include in Stage 2 Review.</p>	
Research findings	<ul style="list-style-type: none"> ▪ Construction date(s): 1912 ▪ Architect: unknown ▪ Builder: unknown ▪ Erected on a large estate for couple Joseph Moore Poyner and Elizabeth Ada Poyner in 1912. Estate formerly belonged to Joseph Poyner’s father, Edward Moore Poyner. ▪ Edward Moore Poyner was a baker and one of the early pioneers of the district. ▪ Estate was put up for auction in 1951 as a 10-roomed residence with extensive outbuildings set on 71 acres of land. Was subsequently purchased by the Maughans. ▪ Antique homewares and art belonging to Willowbank were put up for auction in 2014.

<p>Figure 14. Lauriston (source: Heritage Victoria, n.d.).</p>																						
Integrity	Moderate																							
Condition	Good																							
Strong potential for the following HERCON criteria	<table border="1"> <thead> <tr> <th data-bbox="496 1736 587 1906">A. Historical</th> <th data-bbox="587 1736 678 1906">B. Rarity</th> <th data-bbox="678 1736 769 1906">C. Research</th> <th data-bbox="769 1736 860 1906">D. Representative</th> <th data-bbox="860 1736 951 1906">E. Aesthetic</th> <th data-bbox="951 1736 1042 1906">F. Technical</th> <th data-bbox="1042 1736 1133 1906">G. Social</th> <th data-bbox="1133 1736 1396 1906">H. Associative</th> </tr> </thead> <tbody> <tr> <td data-bbox="496 1906 587 1971">●</td> <td data-bbox="587 1906 678 1971"></td> <td data-bbox="678 1906 769 1971"></td> <td data-bbox="769 1906 860 1971"></td> <td data-bbox="860 1906 951 1971">●</td> <td data-bbox="951 1906 1042 1971"></td> <td data-bbox="1042 1906 1133 1971"></td> <td data-bbox="1133 1906 1396 1971">●</td> </tr> </tbody> </table>								A. Historical	B. Rarity	C. Research	D. Representative	E. Aesthetic	F. Technical	G. Social	H. Associative	●				●			●
A. Historical	B. Rarity	C. Research	D. Representative	E. Aesthetic	F. Technical	G. Social	H. Associative																	
●				●			●																	
Recommendation	Recommended for the Heritage Overlay as an individual place.
