Habitat Tree Feasibility Assessment

Mountain Grey Gum
(*Eucalyptus cypellocarpa*)

3459 Warburton Highway
Warburton, VIC 3799

3rd of April 2023

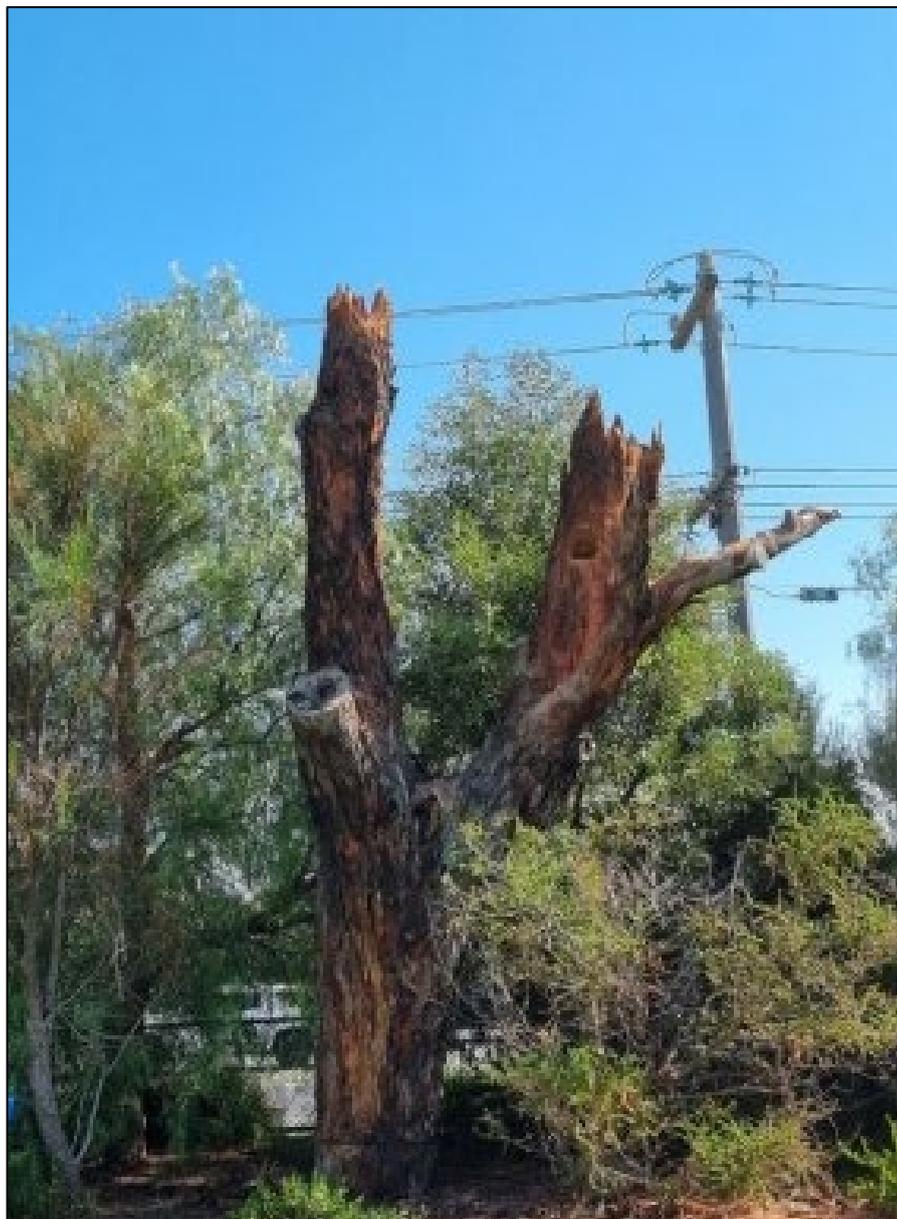
Coronet Cuts

Example of coronet cuts on a hollow-bearing lower trunk and indigenous underplanting at Banksia Reserve, Beaumaris. Undertake by IEA for Bayside City Council, 2022.

- It is recommended that the stubs of the cut trunks are coronet cut. This is a technique that mimics natural breakages, providing a natural aesthetic and habitat for invertebrates. It is also possible to include slits, suitable for microbats (Microchiroptera) in the coronet cut.
